# Staff Report

**Report To:** Committee of the Whole  
**Meeting Date:** April 3, 2017  
**Report Number:** CSPW.17.042  
**Subject:** L.E. Shore Memorial Library Steel Roof Repair Investigation  
**Prepared by:** Aaron McMullen, Facility Manager/Building Maintenance Coordinator

**Re: L. E. Shore Library - 173 Bruce Street South, Thornbury  
Condition of Metal Roofing**

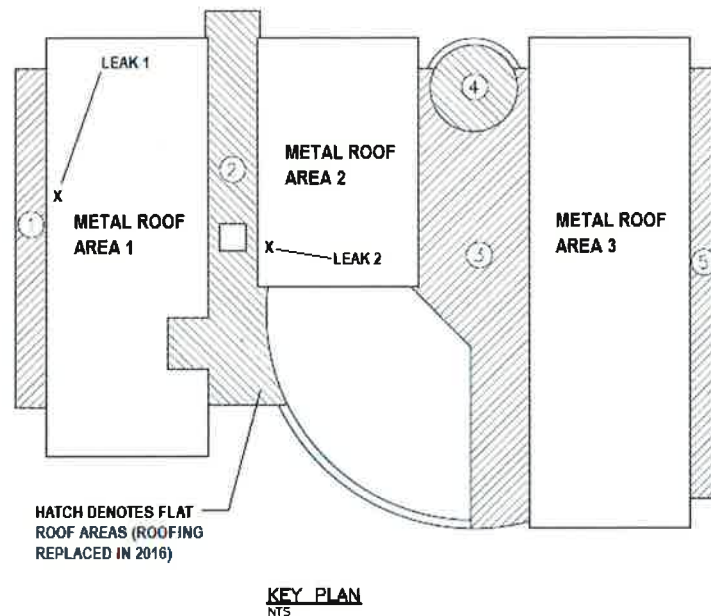
**Figure 1: L. E. Shore Library Key Plan**

- at the location where flat roof area 1 meets metal roof area 1, at approximately the intersection of gridlines 2 and L (see mark on figure 1); and
- at the location where flat roof area 2 meets metal roof area 2, at approximately the intersection of gridlines 4 and K (see mark on figure 1).

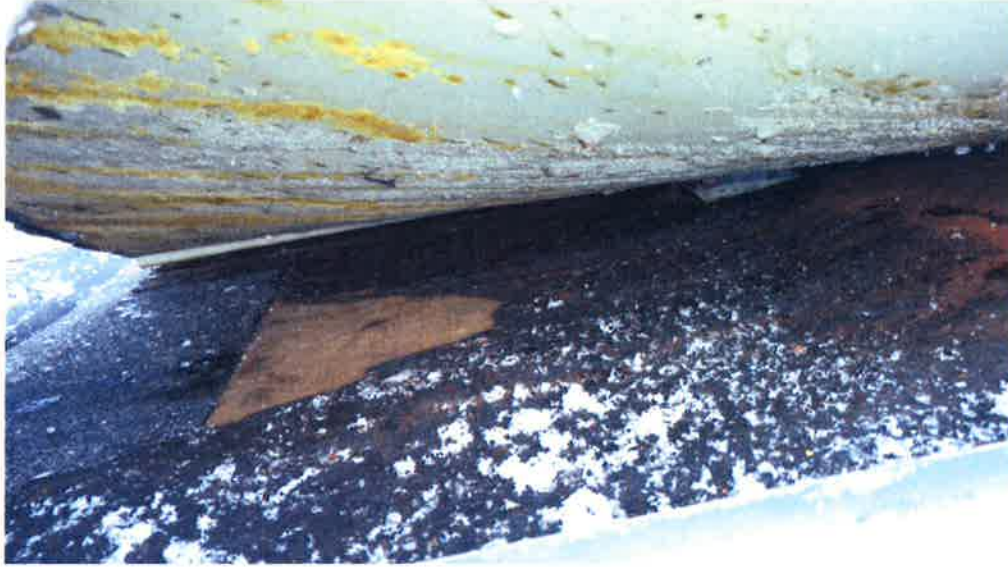
- At both leak locations, the metal roofing was lifted and water was observed on the underside of the roofing and the insulation was found to be saturated (Photograph 1). Water was present well above the location of the flat roof tie-in detail.
- Water was observed running along the surface of the felt paper, coming from above the location where the roofing was lifted (Photograph 2).
- Corrosion was observed on the underside of the metal roofing indicating that moisture has been present for an extended period of time (Photograph 3).
- Water staining was observed on the underside of the wood decking inside the library indicating that the metal roofing has leaked in the past (Photograph 4).

**Photograph 1: Moisture present on the underside of the metal roofing**

- conduct leakage tests on the metal roofing and observe whether additional leaks present themselves;
- remove metal panels to further investigate the extent of moisture penetration in the insulation;
- if the investigations above conclude that little additional leakage and/or condensation/corrosion is observed, then the Town could locally repair the leaks and observe whether further leakage occurs, or proceed with full replacement of the metal roofing; and
- if the investigations conclude that the leakage and/or condensation is widespread, then we recommend the metal roofing be replaced.

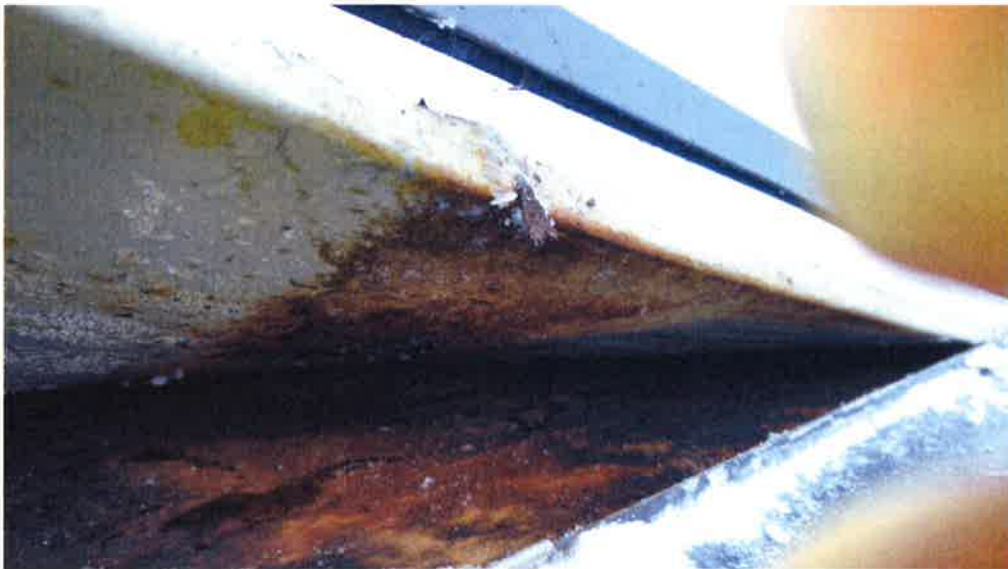
**Photograph 2: Water running along the felt paper**

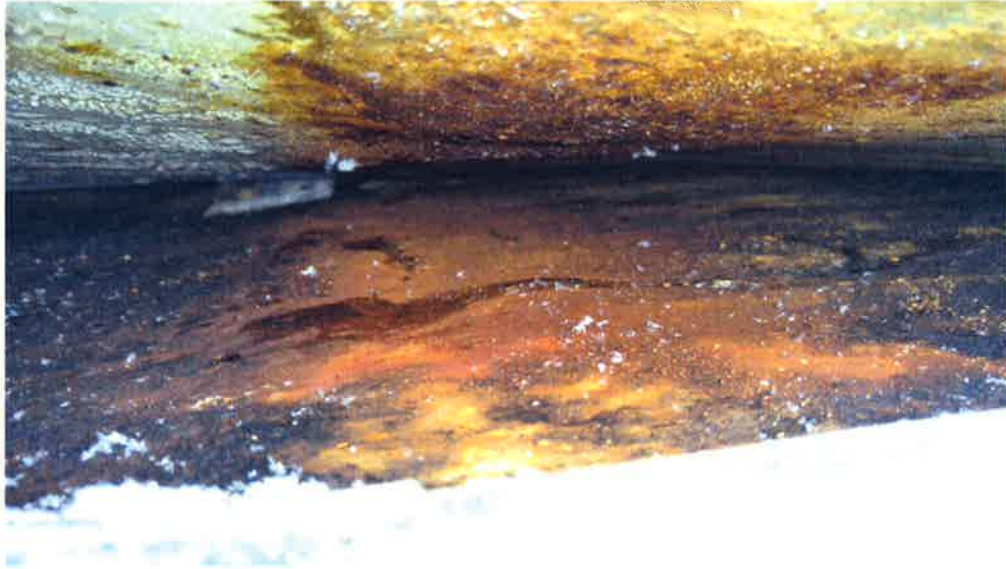
- It is possible that the metal roof seams have shifted and no longer provide adequate protection against rainwater and snow melt penetration. We observed that the metal roof panels are corroded along the seams in several locations indicating water was present and this water could be entering the roofing assembly through the seam, especially wind driven rain.

**Photograph 3:** Corrosion present on the underside of the metal roofing

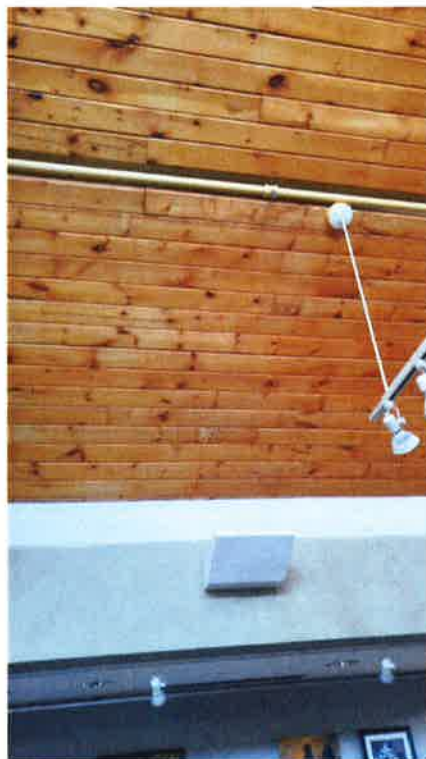
**Photograph 4:** Example of past wood staining on underside of wood planks
