RE: **Town of the Blue Mountains
Emergency Closure of Bridge #16**
Our File No. 29-0685

Date: July 22, 2011 **Pages:** 2 **CCTA File:** 109115-12
To: Jim McCannell The Blue Mountains **Via:** email
Copy: **Via:**
From: Terry Smart, P. Eng.
Subject: Bridge No. 16, 10th Line, Clarksburg
Bearing Seat Repairs

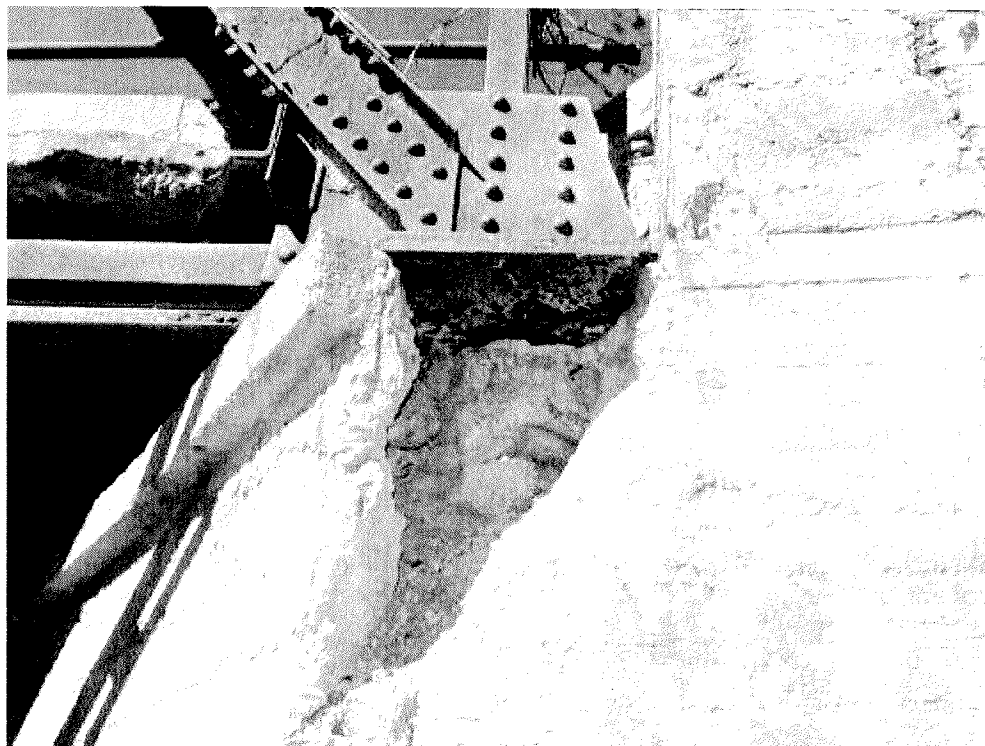
Northeast Corner

- The concrete under bearing at Northeast corner has spalled off and the support has only 50% of the area supported.
- Abutment under bearing at Northwest corner has wide through cracks on both sides of the corner.

These defects were identified as newly developed compared with our 2009 OSIM inspection results. As a single load path structure, failure of the bearing could cause complete structure failure.

An Emergency Repair is required and the structure shall be closed until the work is done to ensure structure stability and public safety.

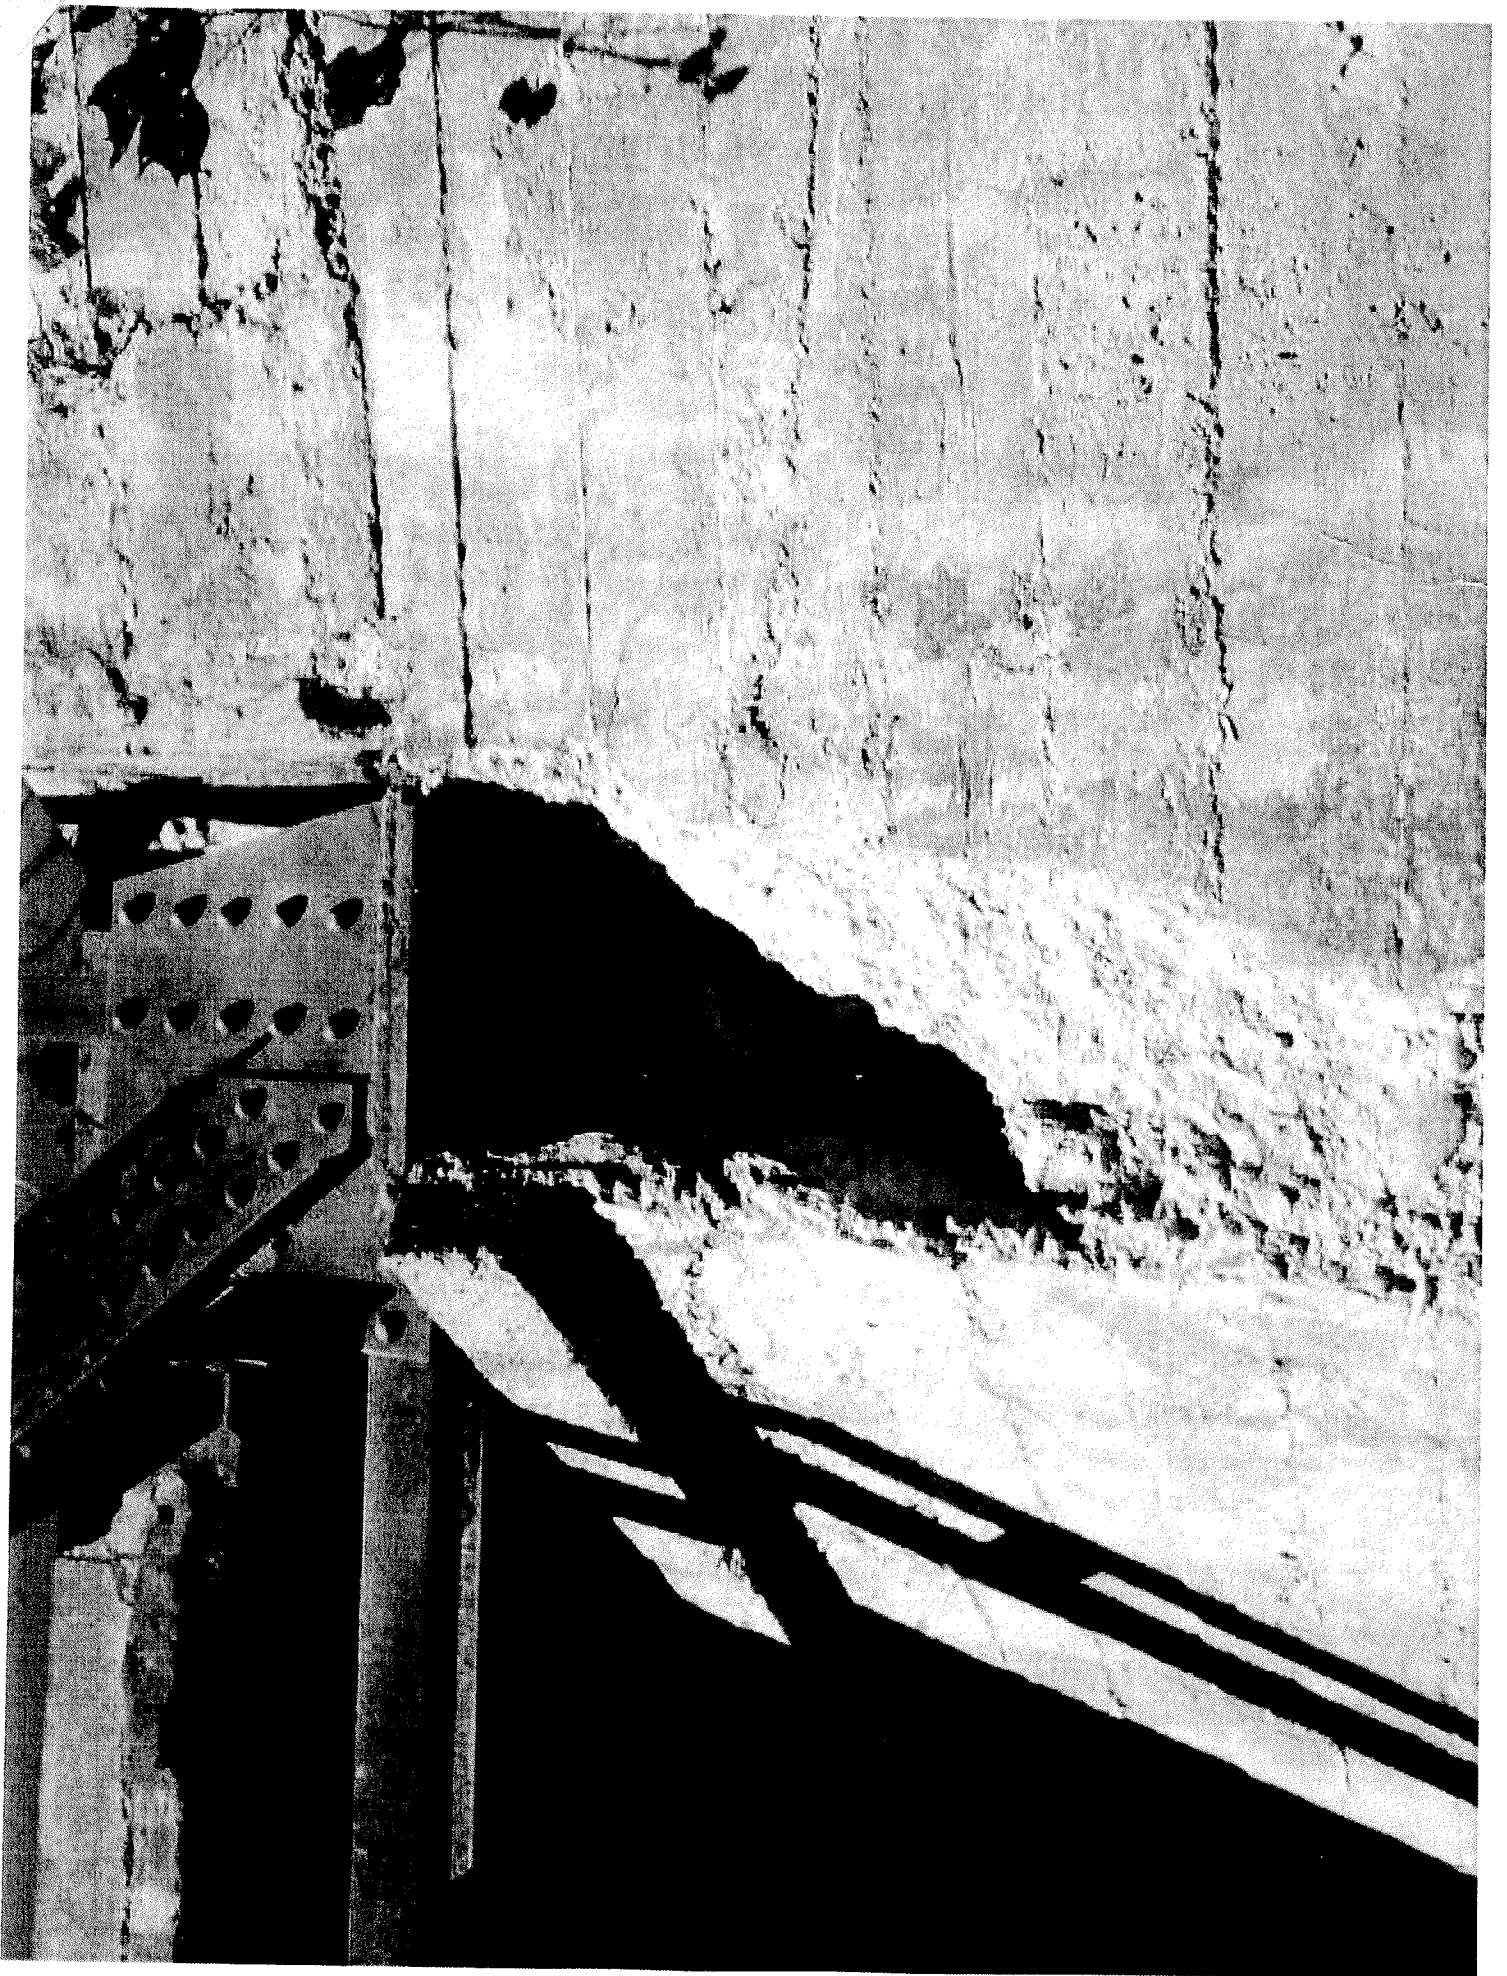
We observed that the north west corner of the abutment has a large section of concrete missing such that the bearing plate for the end of the north through truss has lost approximately 80% of support (see attached photo).

- Jack up the bridge at the west abutment to relieve the load at the bearings. This would likely involve adding temporary brackets to the side of the abutment and bridge to place hydraulic jacks in order to lift the superstructure off the abutment.
- Remove the deteriorated concrete below the north west bearing to sound concrete. Replace with a reinforced bearing seat that is dowelled into the existing sound concrete of the abutment.
- Remove the deteriorated concrete below the south west bearing to sound concrete. This would entail the full height of the abutment. Replace the corner and bearing seat with reinforced concrete that is dowelled into the sound concrete of the abutment.
- Provide anchors between the new bearing seats and the existing bearing plates.

We estimate the cost for the repairs as described above to be \$40,000 to \$50,000 + HST which would include an allowance for professional fees.
