**STAFF REPORT: Community Services**

**REPORT TO:** Council  
**MEETING DATE:** July, 11, 2016  
**REPORT NO.:** CSPW.16.106  
**SUBJECT:** Public Library Roof Repairs  
**PREPARED BY:** Aaron McMullen, Facilities Manager / Building Maintenance Coordinator

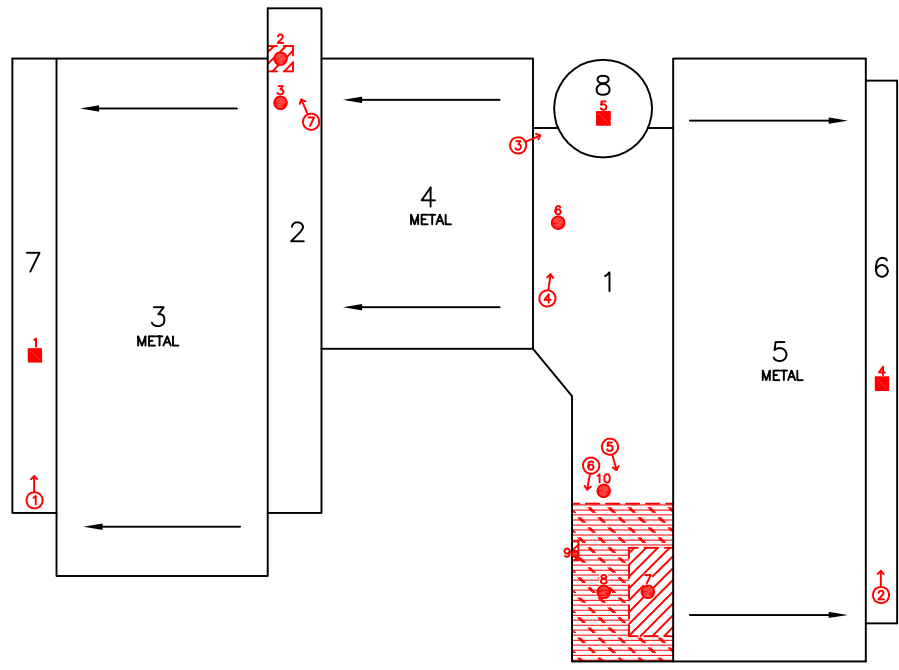
With the organics removed, Thermal Imaging scans and Moisture Probe inspections were performed by Garland Canada. The findings, as shown in Attachment 1 diagram, identify 2 major areas of concern.

Section #1 - shows signs of dampness and wet conditions in a significant area. The wet areas were at the top of the scale.

Section #2 – shows signs of dampness in the area of air quality concern in the Bruce Street vestibule.

TOTAL SQUARE FOOTAGE  
SCANNED: 3,348  
TOTAL SQUARE FOOTAGE  
WET: 416  
ROOF AREAS SCANNED:  
SECTIONS 1, 2, 6, 7 & 8.

Staff recommend that remediation of all flat sections of the L.E. Shore Memorial Library roof occur in the fall of 2016. The recent inspections recommend replacement of the flat portions of roof. Results of the air quality testing indicate that no safety concerns are present at this time. However, it is expected conditions will worsen without any remediation. It is also identified that during roof replacement and remediation of the insulation and membrane in the core of the roofing structure, that there is the strong potential of mould particles be disturbed and becoming airborne within the interior of the building. The closure of the L.E. Shore Memorial Library during remediation works is
