**Re: Supplemental Hydrogeological Investigation to Support SWM Pond Design 125 Arthur Street W, Thornbury, ON**

Palmer Environmental Consulting Group Inc. (Palmer) is pleased to present the results of our Supplemental Hydrogeological Investigation conducted Oct 27, 2021, at 125 Arthur St. W, Thornbury (the “site”).

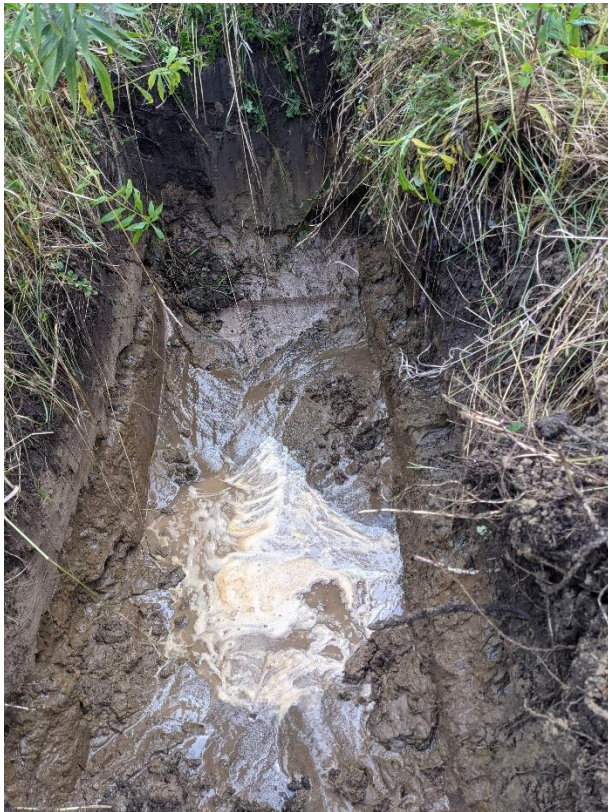
| 1 | 10/27/2021 | |

The observed soil and groundwater conditions were fairly consistent across the site. In each test pit topsoil and a sandy silt layer were encountered to depths between 0.1 to 0.7 meters below ground surface (mbgs). This was followed by a layer of saturated soils consisting of a silty sand that was very loose and rapidly began filling the test pits with perched groundwater. The saturated layer was encountered at depths of ranging from 0.2 to 0.85 mbgs in TP-1 to TP- 4. The silty sand unit was not encountered in TP-5; however, the saturated conditions were present in the upper topsoil layer.

| TP-1, rapidly filling with perched groundwater form the saturated layer at 0.5 meters below ground surface (mbgs). | | |

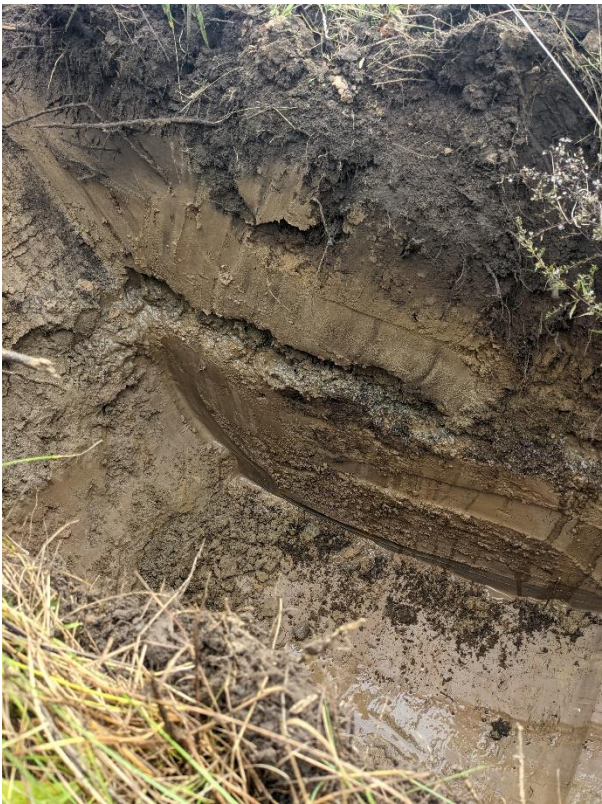
Below the saturated conditions, a layer of silty clay to clayey silt was encountered in all test pits at depths ranging from 0.1-0.85 mbgs. This layer was compact and dense, acting as an aquitard due to its low hydraulic conductivity. The silty clay layer was observed in two (2) of the test pits to become grey at a depth of 1.5 mbgs (TP-2 and TP-5). The change in colour from brown to grey is an indicator of permanently saturated conditions in the soils.

| <p>TP-2, soil stratigraphy. The loose saturated layer can be seen falling into the test pit from 0.7mbgs to 0.85 mbgs. Perched groundwater is infiltrating from this layer. Above is the topsoil and sandy silt layer. Bellow is the Silty Clay layer acting as an aquitard. The soil at the bottom of this test pit (1.5 mbgs), is grey indicating permanently saturated conditions.</p> | | |

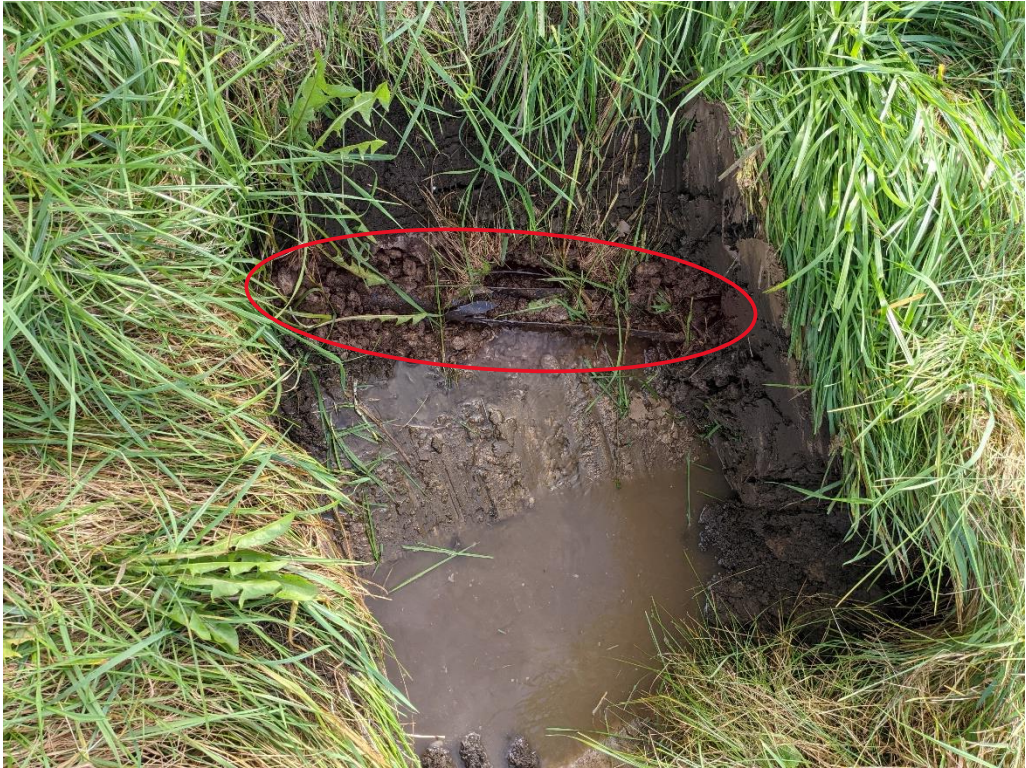
| <b>Photo #:</b><br><b>3</b> | <b>Date.</b><br>10/27/2021 |

Standing water was also encountered on site at surface in multiple locations. This is expected to have been caused by the recent heavy rainfall and low permeability soils near surface. A plastic weeping tile was encountered in the vicinity of TP-3 in the northwestern field at a depth of 0.1 mbgs.

| <b>Description</b><br>TP-3, weeping tile encountered 0.10 mbgs. | |

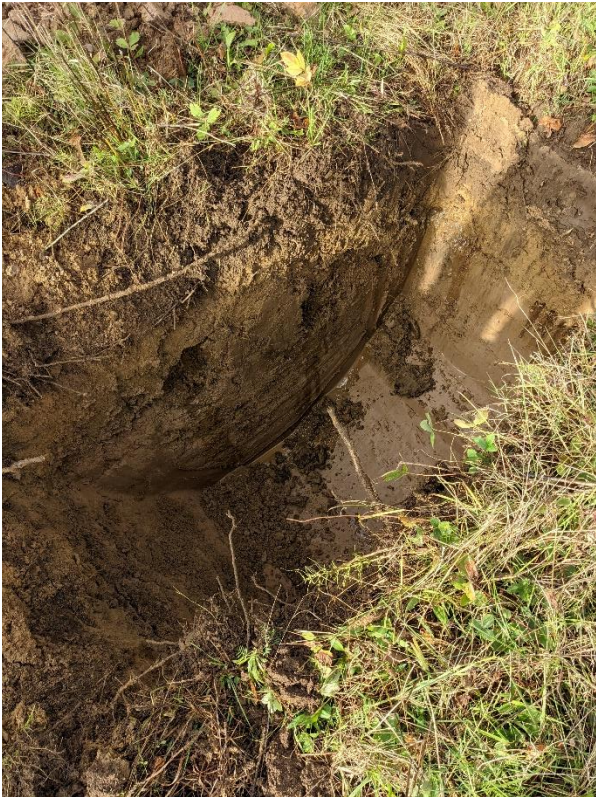
| <b>Description</b><br>TP-4, Soil stratigraphy. The 3 main layers can be seen here. The topsoil and sandy silt layer extends from surface to 0.3 mbgs where the perched groundwater and saturated silty sand layer was encountered. In this test pit the saturated layer was found to depth of 0.5 mbgs where the mottled silty clay layer was encountered. | |

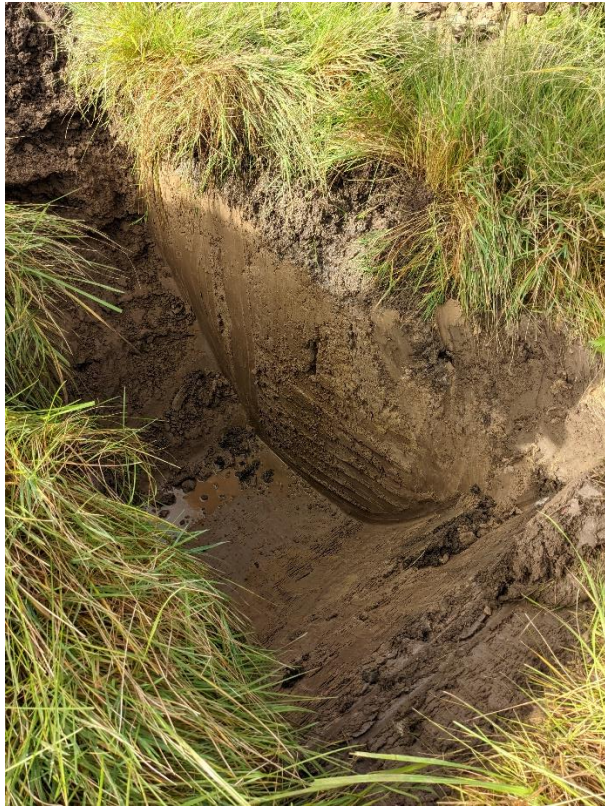
| <b>Description</b><br>TP-5, at this location the groundwater was observed to be infiltrating from the topsoil layer at a depth of 0.1 mbgs. The groundwater is perched on a mottled silty clay layer. The silty clay soils become a clayey silt and transition from mottled to grey at a depth of 1.5 mbgs. This is evidence of permanently saturated soil conditions. | | |

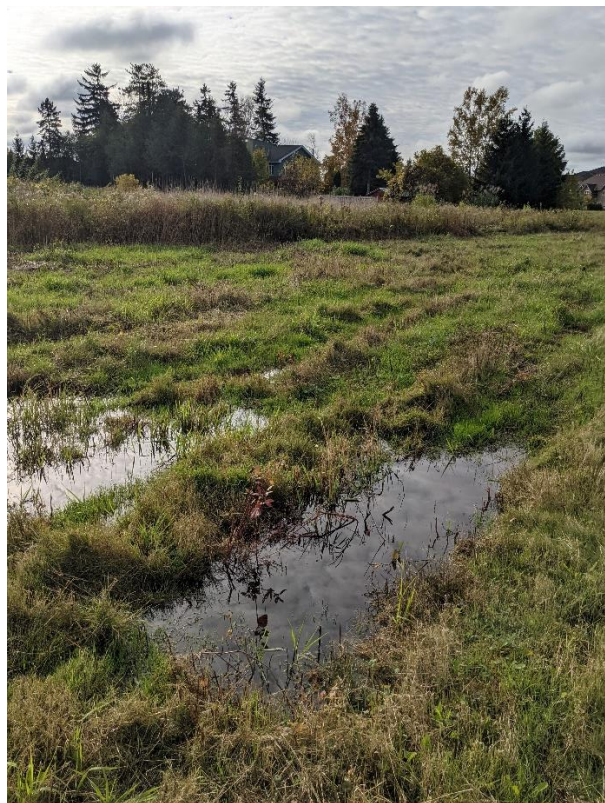
| 6 | 10/27/2021 | |

| Standing water observed on site. | | |
