December 10, 2021

**Re:** D-4 Guideline Landfill Impact Assessment, 125 Arthur Street West and 123 Louisa Street West, Thornbury, ON  
**Project #:** 2105901

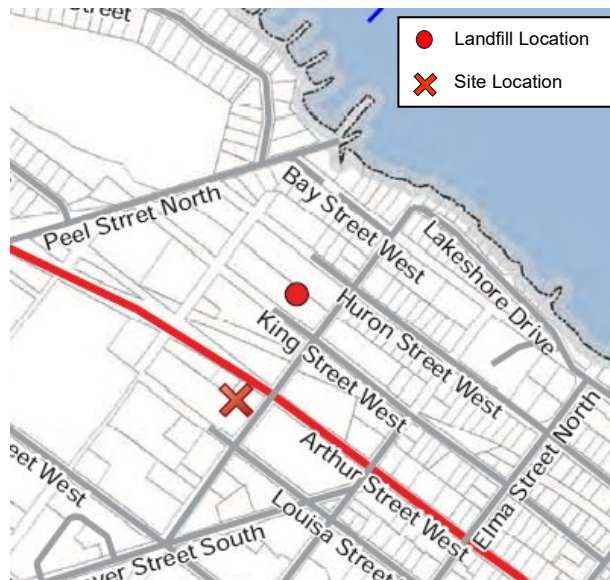
*Figure 1. Landfill Location Map*

**Table 1** and **Figure 1** below identifies the landfill operations located within 500 m of the Site.

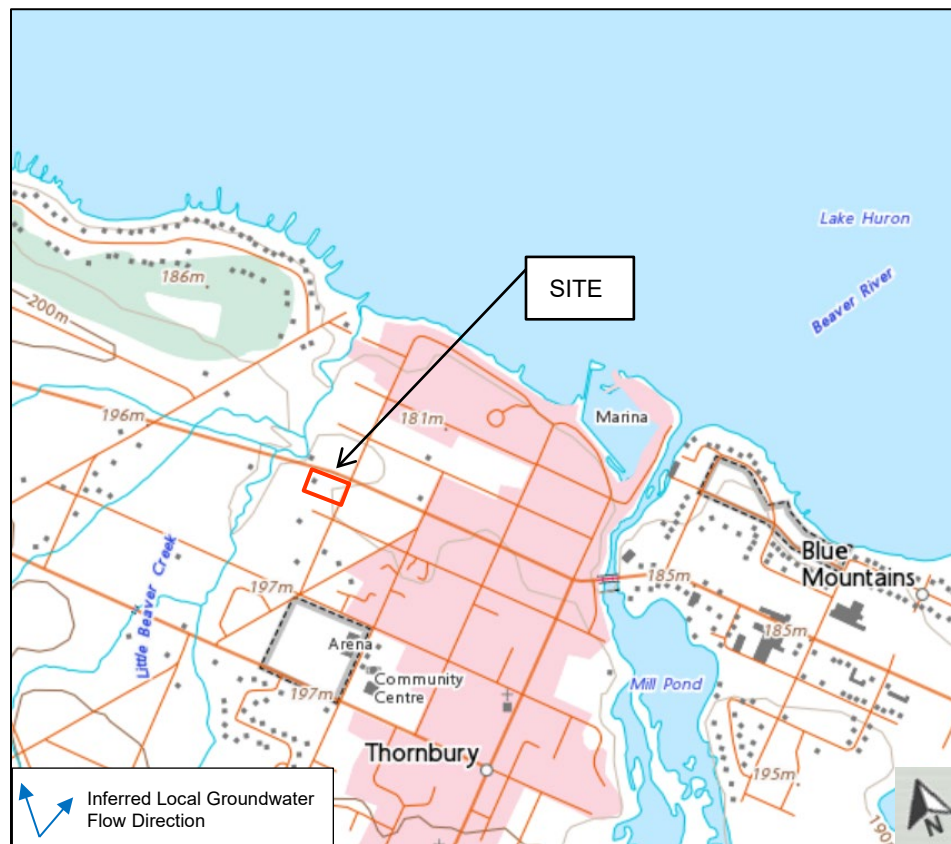
**Figure 2. Topographic Map**

The Site location is shown on the Atlas of Canada Topographic Map, as presented in **Figure 2** below. The surface elevation of the Site is approximately 190 metres above mean sea level (amsl). Topography across the Site is relatively flat, and the topography in the vicinity of the Site slopes gradually downward to the north and east.
