## Phase One Environmental Site Assessment

125 Arthur Street West, 123 Louisa Street West and  
Surrounding Vacant Land, Thornbury, Ontario  
G2S20445

## Executive Summary

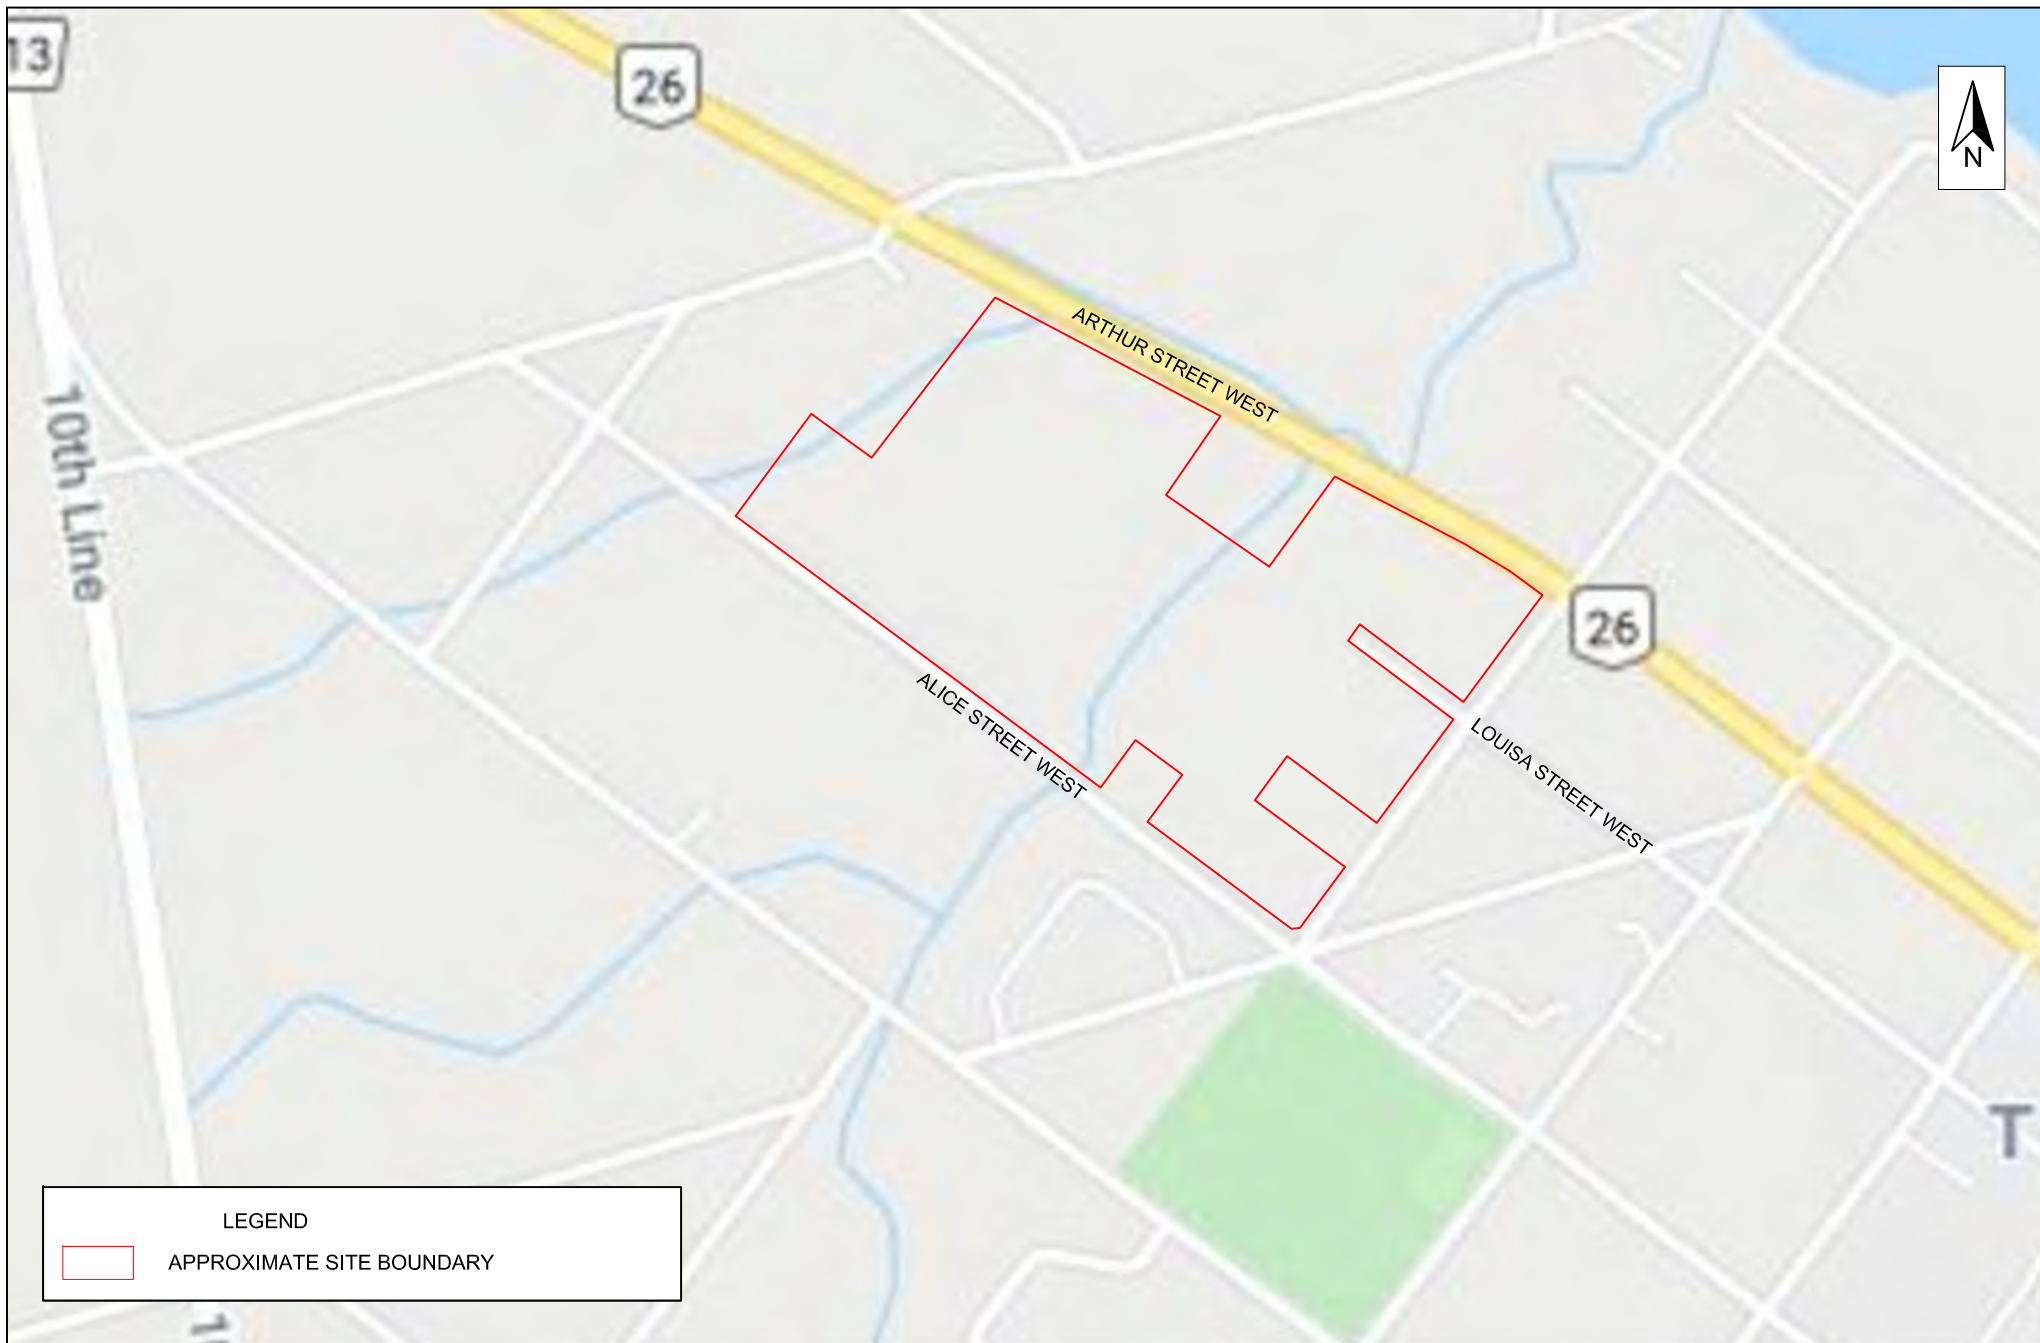
125 ARTHUR STREET W, 123 LOUISA STREET WEST  
 AND SURROUNDING VACANT LAND  
**SITE LOCATION PLAN**

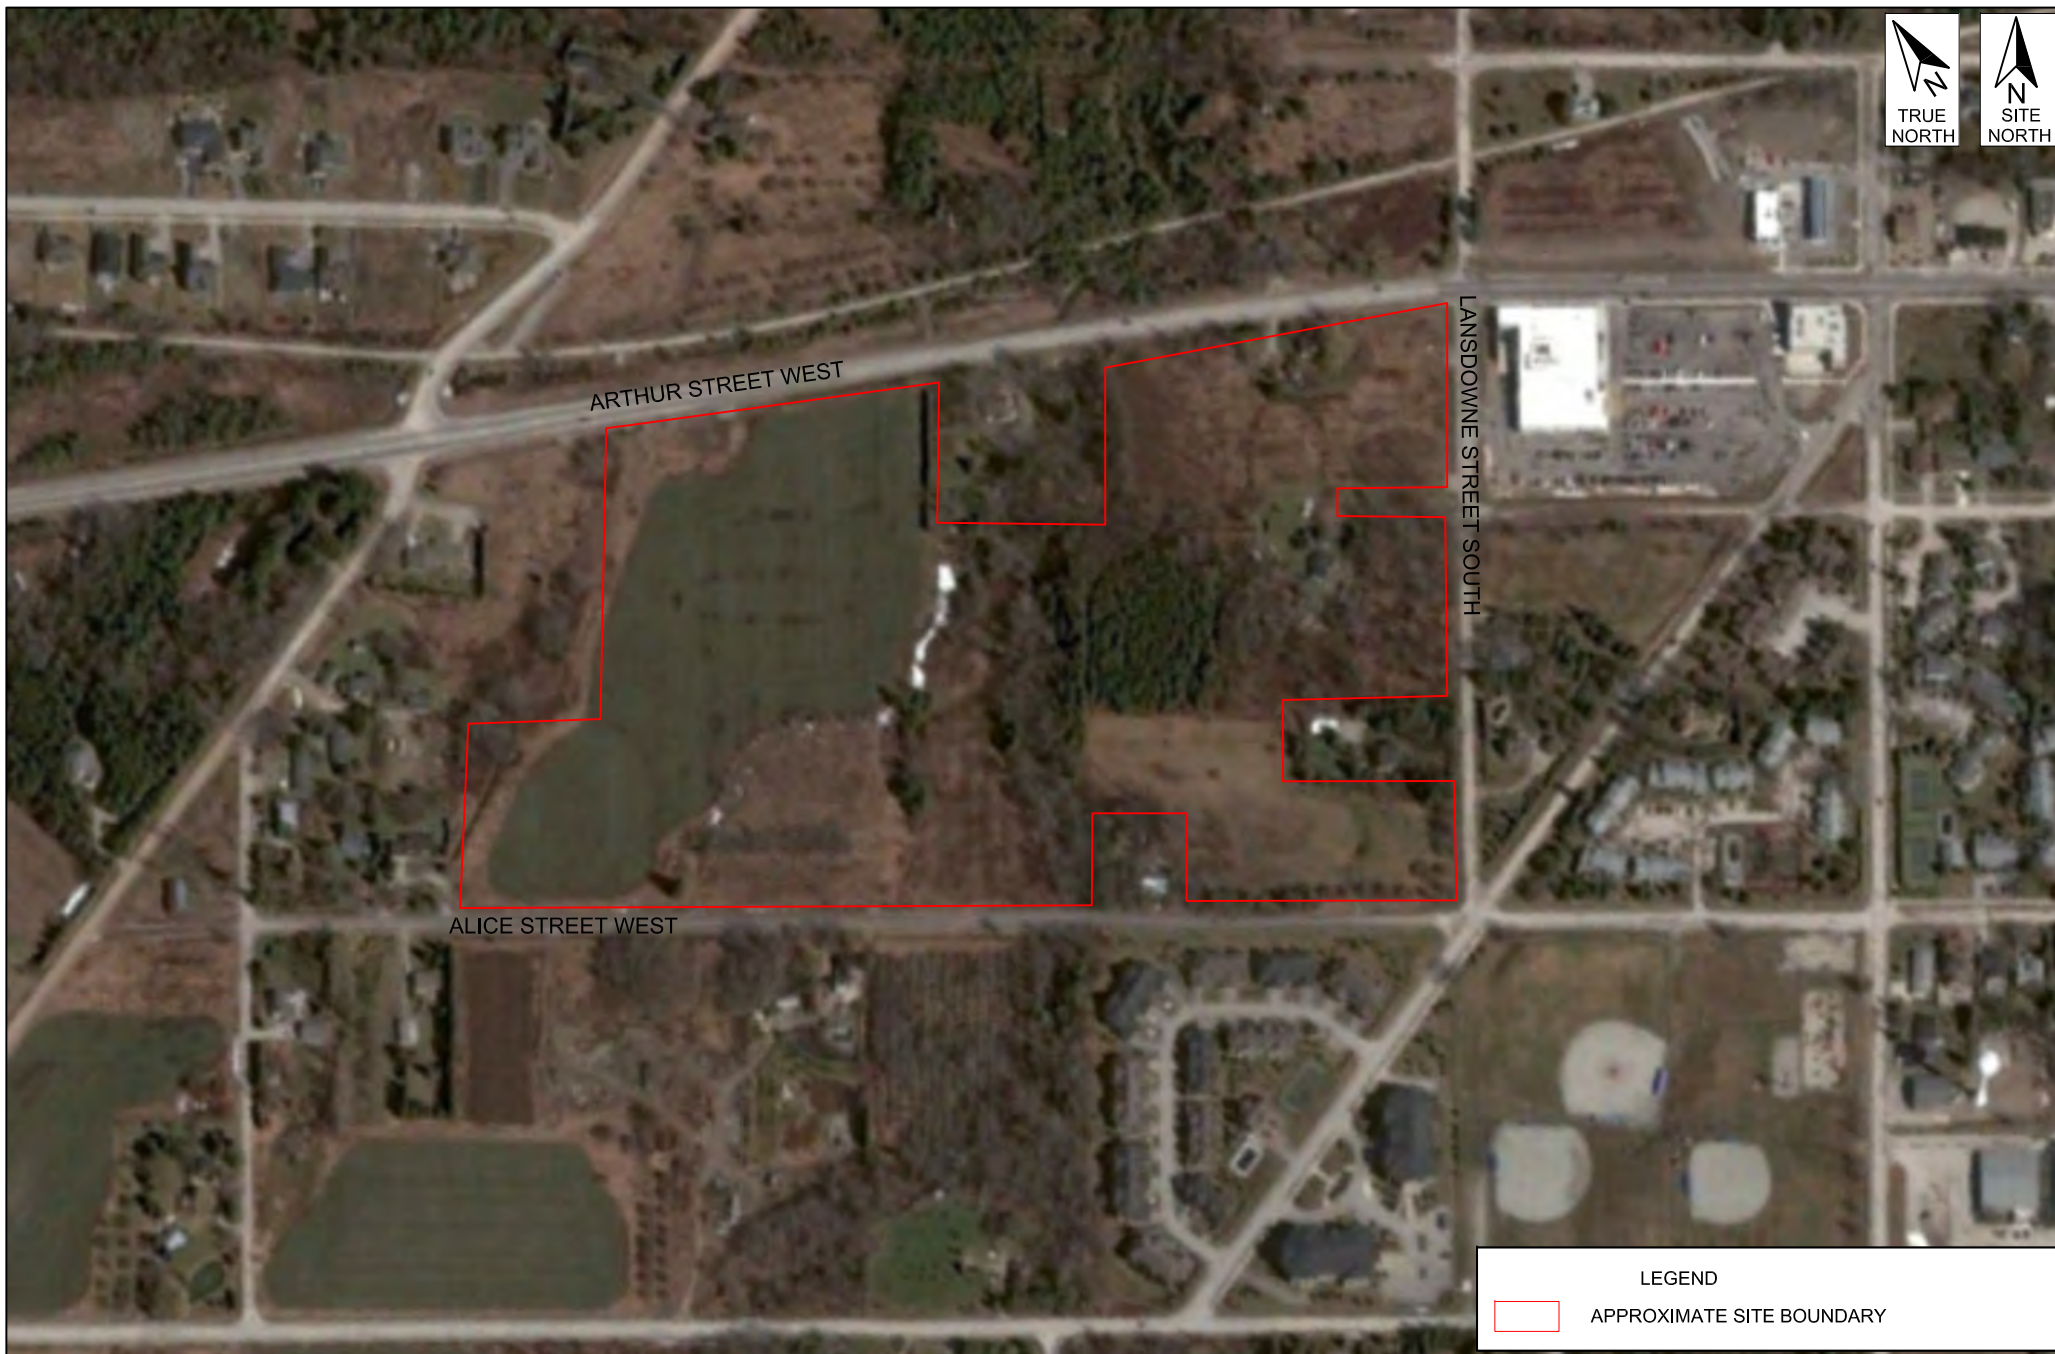
125 ARTHUR STREET W, 123 LOUISA STREET WEST  
AND SURROUNDING VACANT LAND  
2016 AERIAL PHOTOGRAPH

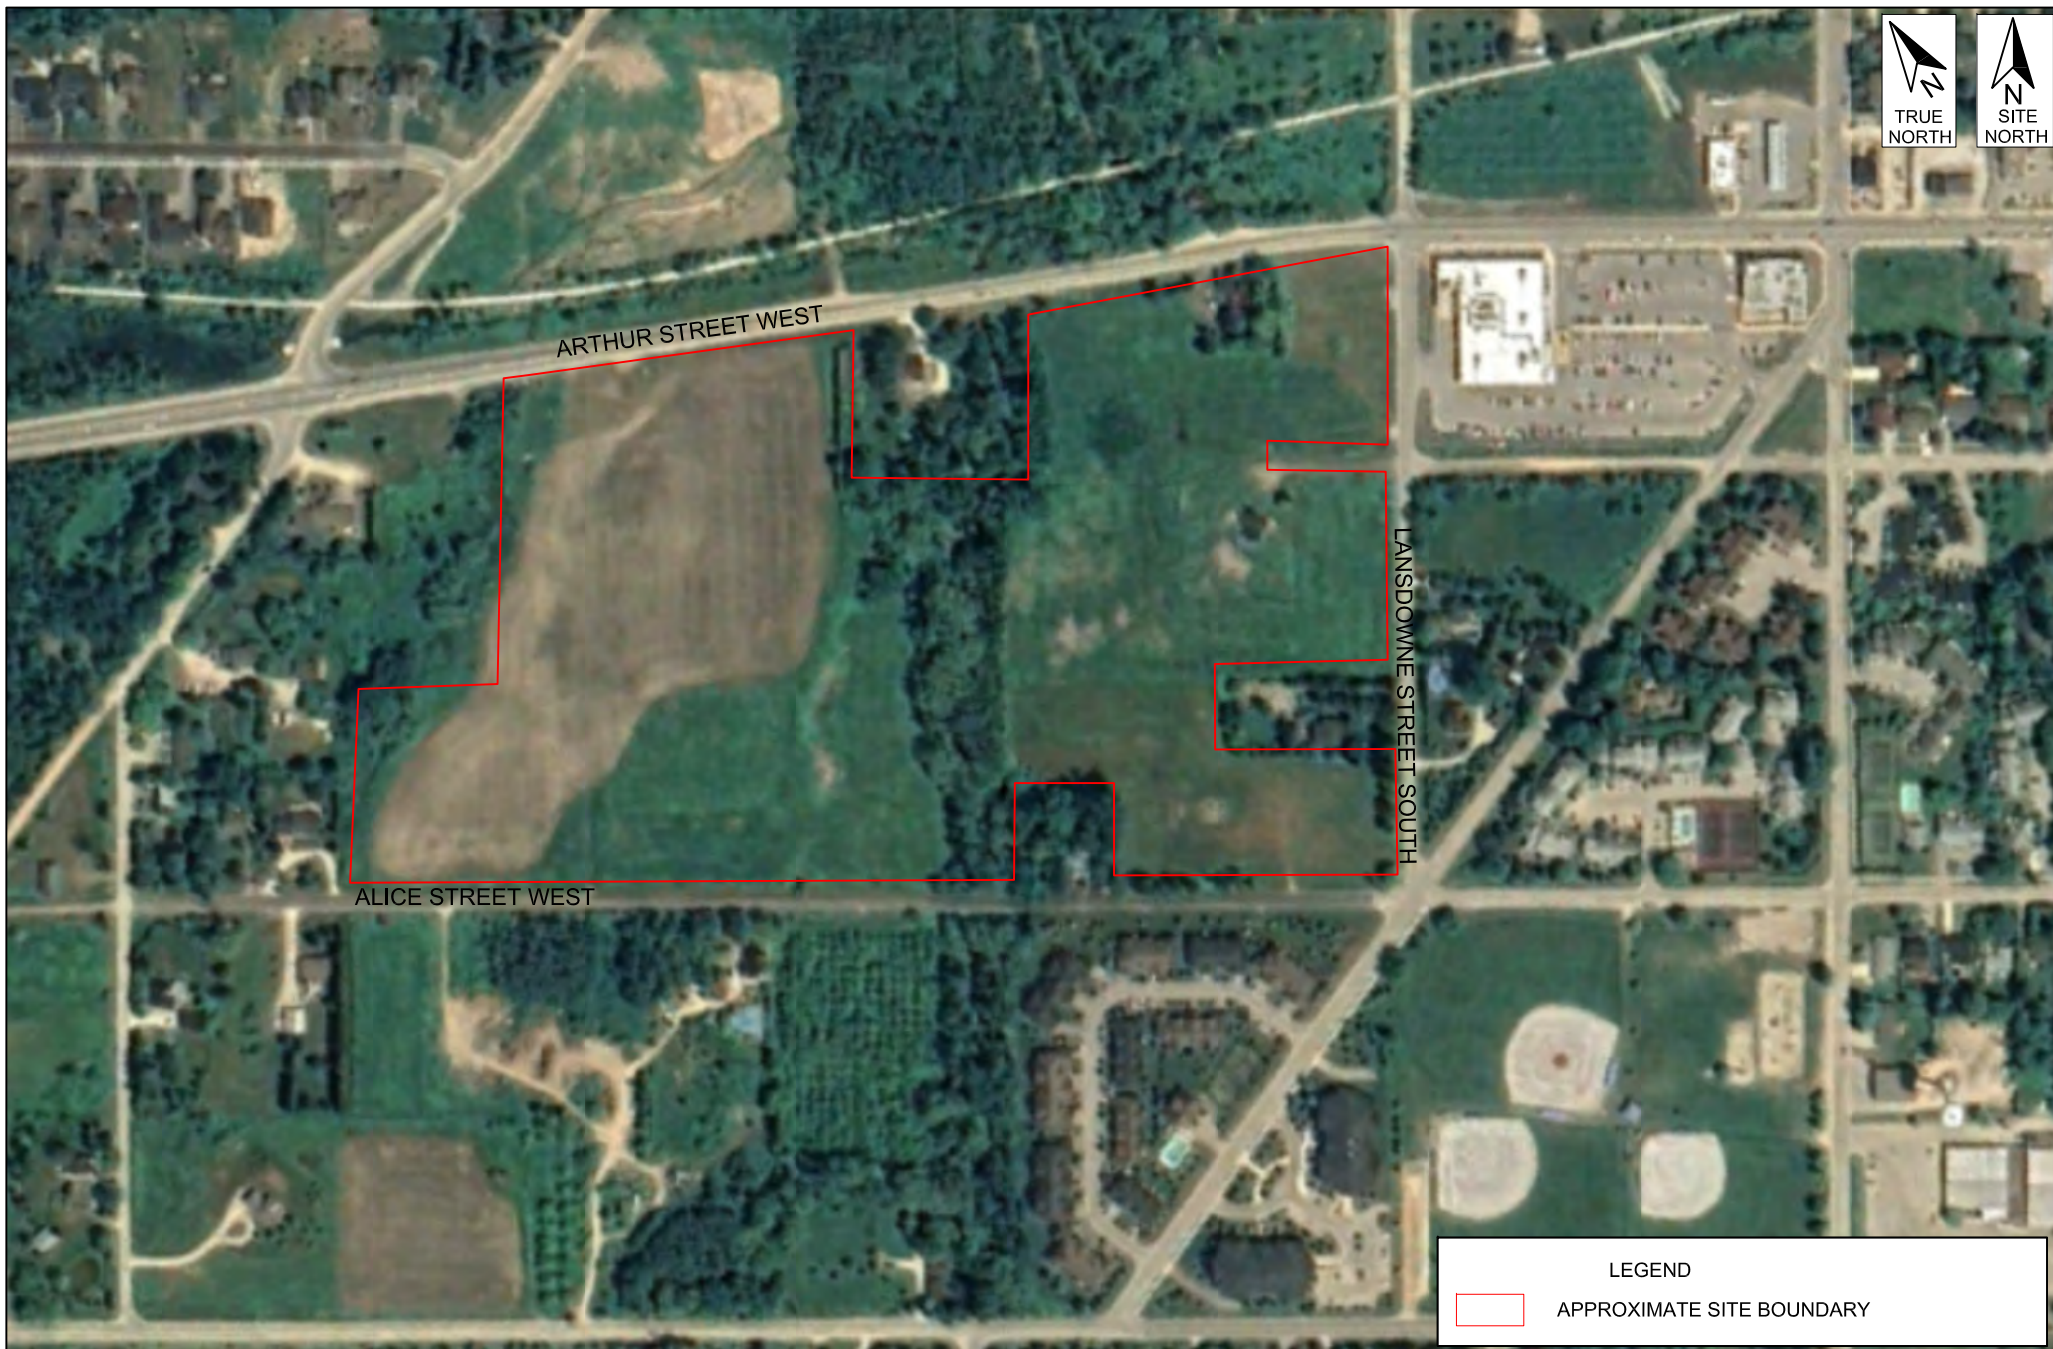
125 ARTHUR STREET W, 123 LOUISA STREET WEST  
 AND SURROUNDING VACANT LAND  
 2019 AERIAL PHOTOGRAPH

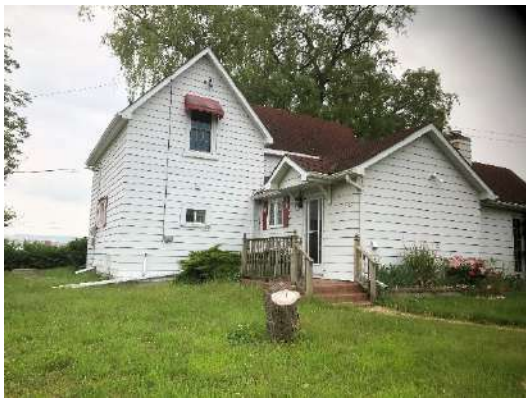
| Picture and Description | |
|---|---|
| <b>Photo #1:</b> 125 Arthur Street West, western portion of the residential building. | <b>Photo #2:</b> Western portion of 125 Arthur Street West. |

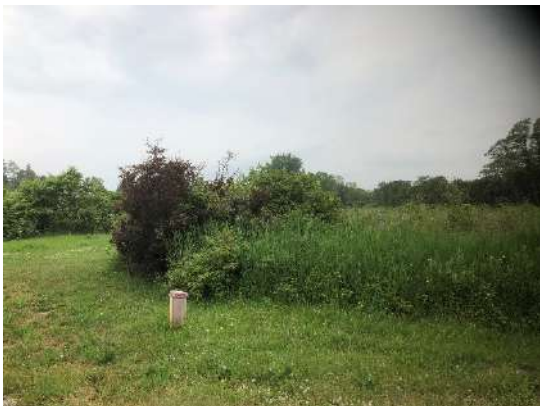
125 Arthur Street West is serviced by a potable well located to the southwest of the residential building on-Site. It is likely that 123 Louisa Street West is also serviced by a potable well, although no well was observed during the Site visit due to overgrown wild grasses.

| Picture and Description | |
|---|---|
| <b>Photo #3:</b> Well located at 125 Arthur Street West. | <b>Photo #4:</b> Northern portion of the Site, facing west. |

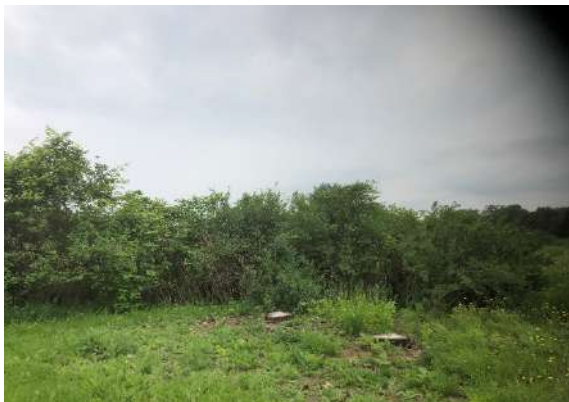
| Picture and Description | |
|---|---|
| <b>Photo #5:</b> Northern portion of the Site, facing south. | <b>Photo #6:</b> Southern portion of the 125 Arthur Street West, facing east. |

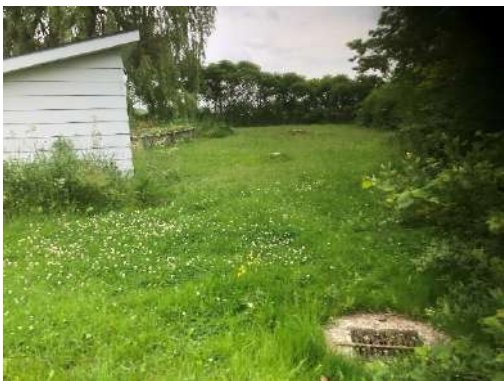
No pits and/or lagoons were observed during our Site visit. A storm drain was identified south of the residential building located at 125 Arthur Street West.

| Picture and Description | |
|---|---|
| <b>Photo #7:</b> Storm drain located south of the residential building. | <b>Photo #8:</b> Eastern portion of the Site, facing south. |

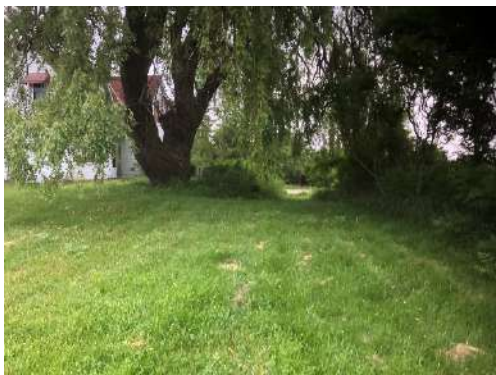
| Picture and Description | |
|---|---|
| <b>Photo #9:</b> Eastern portion of 125 Arthur Street West, facing north. | <b>Photo #10:</b> Eastern portion of the residential building, located at 125 Arthur Street West. |

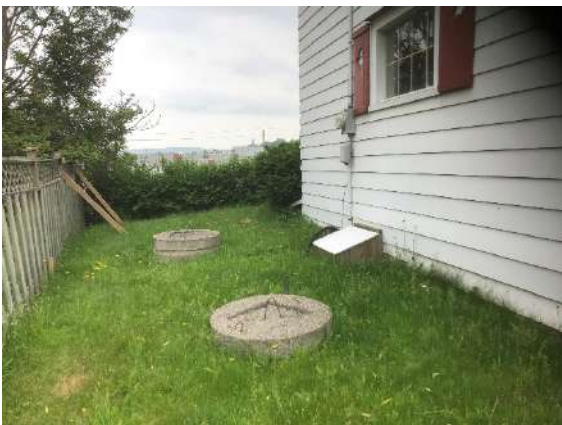
| Picture and Description | |
|---|---|
| <b>Photo #11:</b> Two cement cisterns, north of the residential building. | <b>Photo #12:</b> Kitchen located at 125 Arthur Street West. |

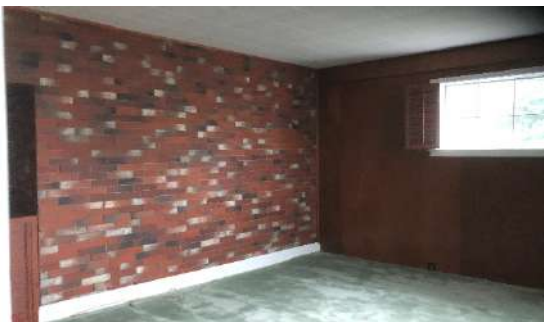
| Picture and Description | |
|---|---|
| <b>Photo #13:</b> Eastern portion of the residential building located at 125 Arthur Street West. | <b>Photo #14:</b> Bedroom located at 125 Arthur Street West. |

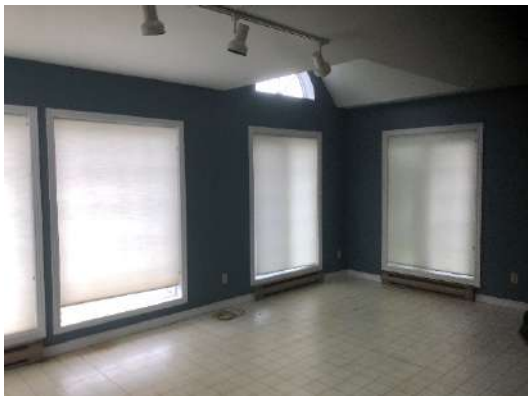
| Picture and Description | |
|---|---|
| <b>Photo #15:</b> Southern portion of the residential building located at 125 Arthur Street West. | <b>Photo #16:</b> Basement located at 125 Arthur Street West. |

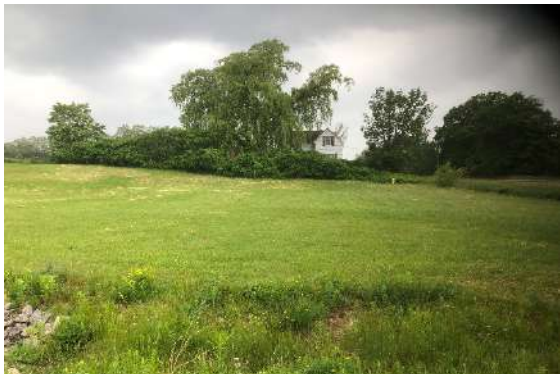
| Picture and Description | |
|---|---|
| <b>Photo #17:</b> Northeast portion of the Site. | <b>Photo #18:</b> Single car garage located at 123 Louisa Street West. |

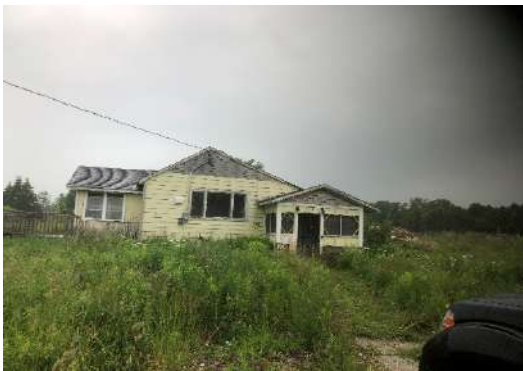
| Picture and Description | |
|---|---|
| <b>Photo #19:</b> Northern portion of 123 Louisa Street West, facing south. | <b>Photo #20:</b> Western portion of the residential building located at 123 Louisa Street West. |

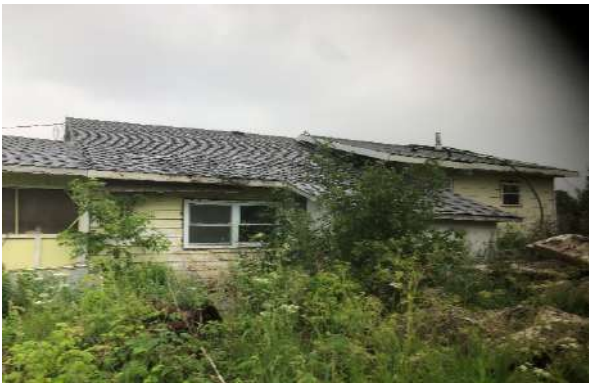
123 Louisa Street West stored five car batteries and approximately 40 cans of paint in the western portion of the house. A pile of cinder blocks and wood was located west of the residential building on-Site. No other materials were observed to be stored on-Site.

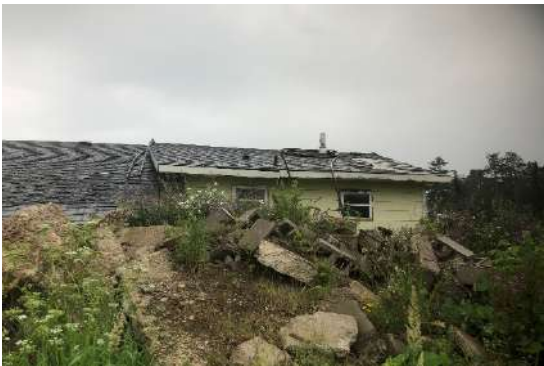
| Picture and Description | |
|---|---|
| <b>Photo #21:</b> Pile of cement blocks and wood located west of the residential building at 123 Louisa Street West. | <b>Photo #22:</b> Central portion of the Site. |

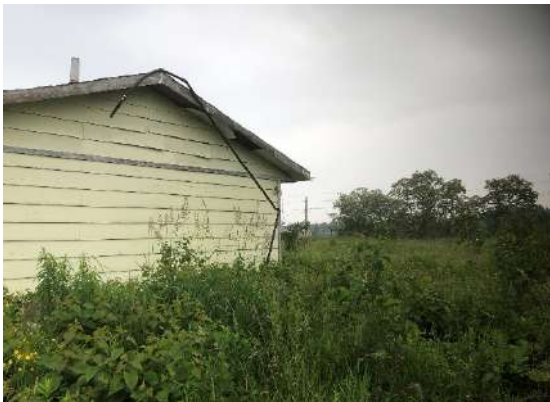
| Picture and Description | |
|---|---|
| <b>Photo #23:</b> Southern portion of 123 Louisa Street West. | <b>Photo #24:</b> Northern portion of 123 Louisa Street West. |

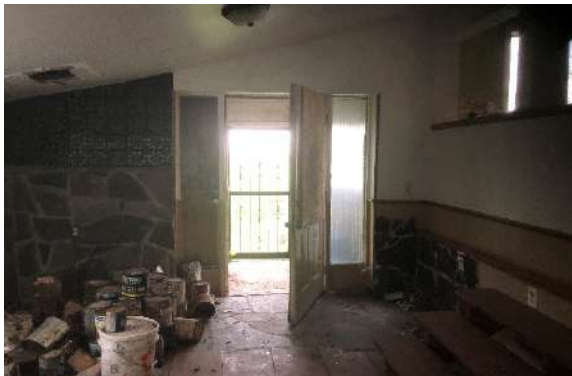
Evidence of mould was observed at the residential building at 123 Louisa Street West in the front porch of the building located at the northern portion of the house, and in various rooms of the residence. Windows are all broken, floors are sunken in and some of the roof appeared to be caving in. Water damage was visible in various rooms of the residence.

| Picture and Description | |
|---|---|
| <b>Photo #25:</b> Northern portion of the residential building located at 123 Louisa Street West. | <b>Photo #26:</b> Northern portion of the residential building located at 123 Louisa Street West. |

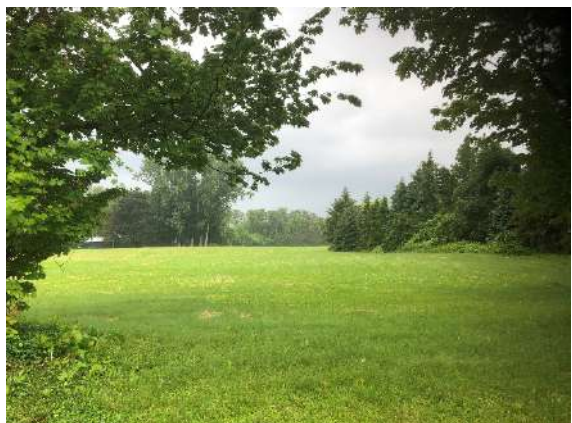
| Picture and Description | |
|---|---|
| <b>Photo #29:</b> Southeast portion of the Site. | <b>Photo #30:</b> South central portion of the Site. |

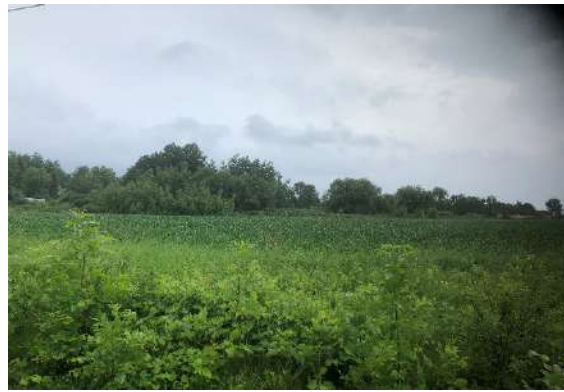
**Photo #31:** Western portion of the Site.
