**SLOPE STABILITY ASSESSMENT
PROPOSED RESIDENTIAL SUBDIVISION
161 LAKESHORE ROAD EAST
TOWN OF THE BLUE MOUNTAINS, ONTARIO**

PML Ref.: 15BF041
Report: 3
December 2016

**Slope Stability Assessment
Proposed Residential Subdivision
161 Lakeshore Road East
Town of The Blue Mountains, Ontario**

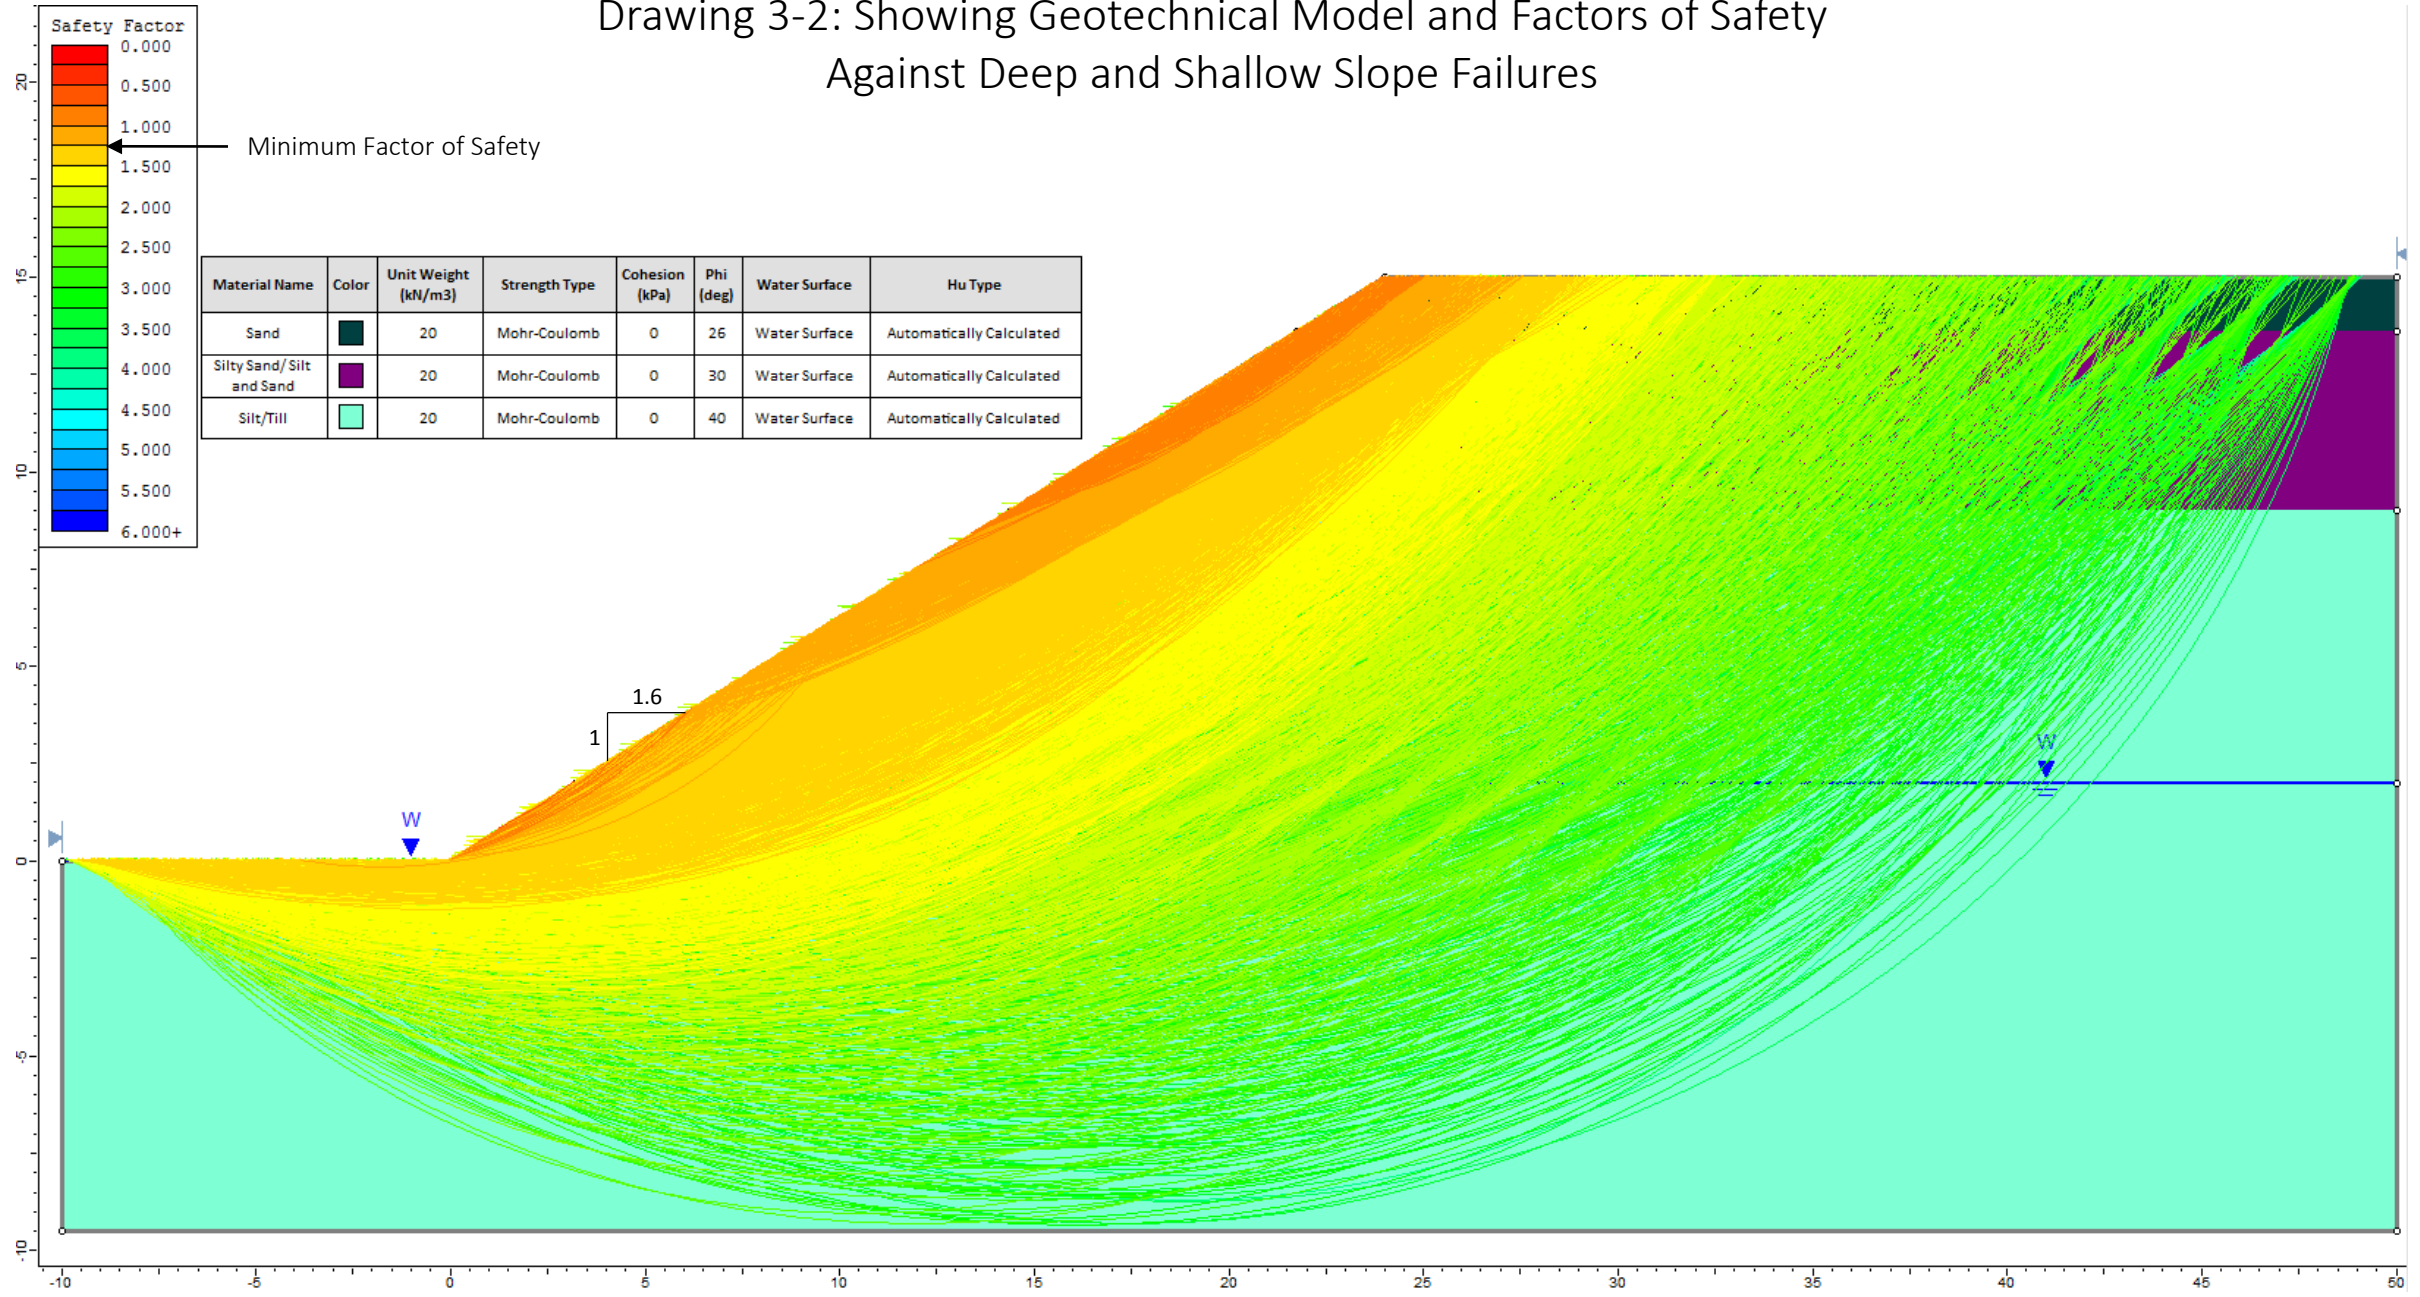
Drawing 3-2: Showing Geotechnical Model and Factors of Safety
Against Deep and Shallow Slope Failures

The Slide V7.0 software computes the factor of safety for a near infinite number of trial slides at varying depths in the slope. The results of the analysis are provided graphically on the appended Drawing 3-2, which shows the existing slope is stable (FS of 1.3 or greater), against an overall deep seated slope failure.

The analysis does show the potential for local shallow slides at the surface of the slope. However, we do note that there was no obvious evidence of any surface movement during our site visit, and this may be the result of the stabilizing effect of surface vegetation and root mat.

A detailed analysis was carried out based on the geotechnical model development from the boreholes and visual findings, and utilizing Slide V7.0 software. Based on the MNR Technical Guide the land use at the top of the slope is considered ACTIVE - habitable or occupied residential or commercial structures will be near the top of the slope, where the recommended design minimum slope stability Factor of Safety (FS) is 1.3.
