## Appendix C – Tree Preservation Plan

LOT 31 CLARK ST  
Town of the Blue Mountains, ON

TREE INVENTORY/ PRESERVATION PLAN

**RE: Proposed Commercial/Industrial Development  
Lot 31 Clark Street, Town of Blue Mountains  
Project No. 2200901**

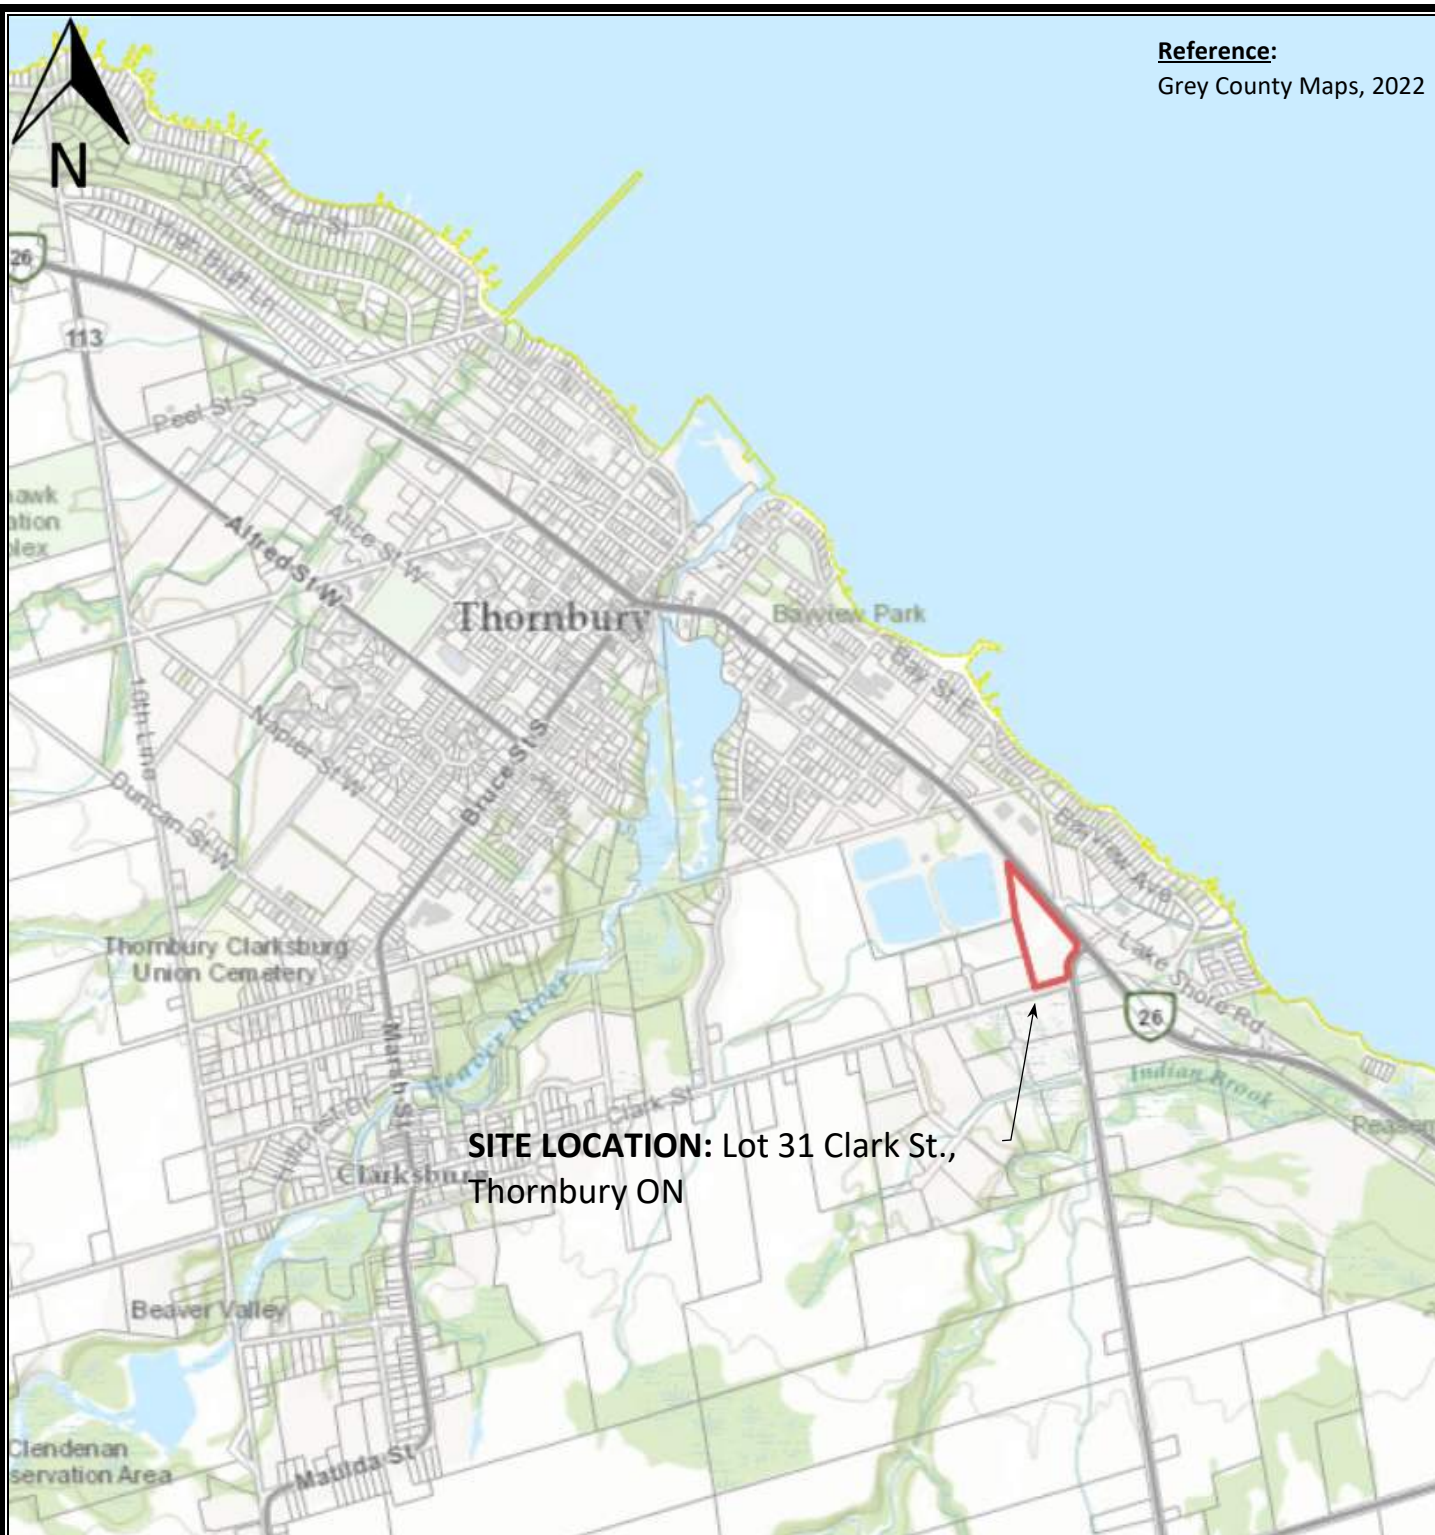
## **ENCLOSURE 1**

Site Location Plan, Test Pit Location Plan

GEI Consultants was retained to carry out in-situ soil infiltration testing at Lot 31 Clark Street, in the Town of the Blue Mountains. A site location plan is provided as Figure 1 in Enclosure 1. The property is irregular in shape approximately 160 metres wide (east to west) and 400 metres long (north to south). The property is bounded by Clark Street and Grey Road 2 to the south and southeast, undeveloped properties to the west, and Highway 26 to the northeast. The property is vacant with some grass/trees throughout the property and a dirt road for access to the south. The property is currently used for storage of construction equipment and vehicles.

Measurement of the field-saturated hydraulic conductivity ( $K_{fs}$ ) was carried out in Test Pits 1 and 4 using a Guelph Permeameter apparatus (Model 2800K1) on March 28, 2022. The test locations are shown on Figure 2. The test pits were excavated by a contractor retained by GEI. In discussion with the civil engineer, potential LID infiltration elevations were unknown, so depths of 1.5 metres below grade were assumed for the purposes of the Guelph Permeameter testing. Sandy silt glacial till was encountered at depths of 0.8 to 1.6 metres below grade, and groundwater seepage was encountered at 0.8 to 1.2 metres below grade in Test Pits 1 to 3. The stratigraphy is summarized in Section 2 above.

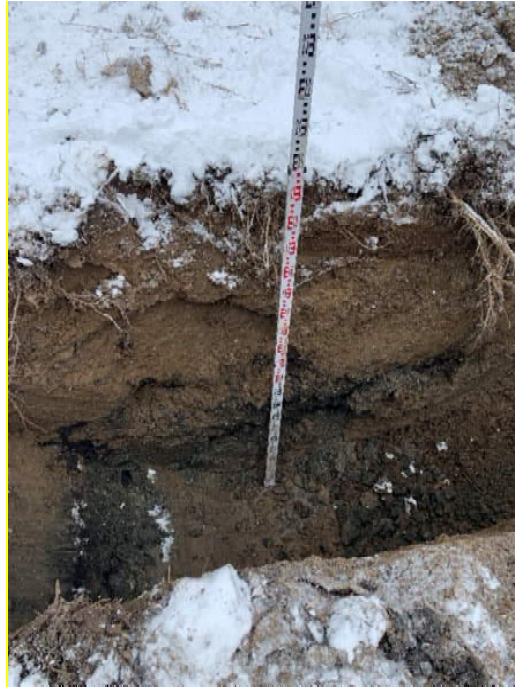
**PHOTOGRAPH 1**

**Description:**  
Detailed View of  
Test Pit #1.

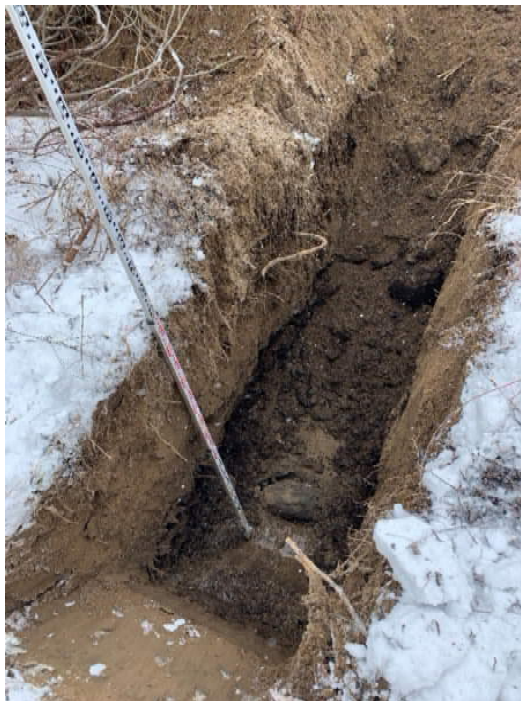
**PHOTOGRAPH 2**

**Description:**  
Detailed View of  
Test Pit #2.  
Groundwater  
seepage is visible  
at the base of the  
test pit.

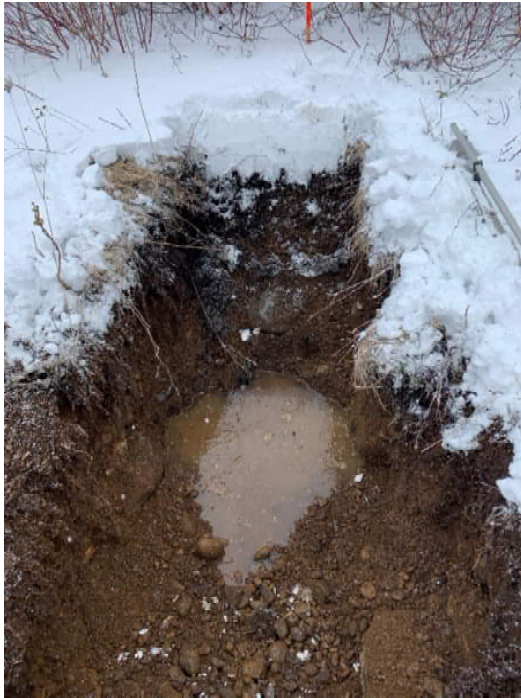
**PHOTOGRAPH 3**

**Description:**  
View of Test Pit #3. Groundwater seepage is visible at the base of the test pit.
