**Re: Slope Stability Assessment – 192 Hidden Lake Road, Town of Blue Mountains, ON**  
**Cambium Reference: 02605305.000**

Cambium Inc. (Cambium) is pleased to provide you with this letter detailing the findings of a visual slope stability assessment and slope analysis conducted at 192 Hidden Lake Road, in the Town of Blue Mountains, Ontario (Site).

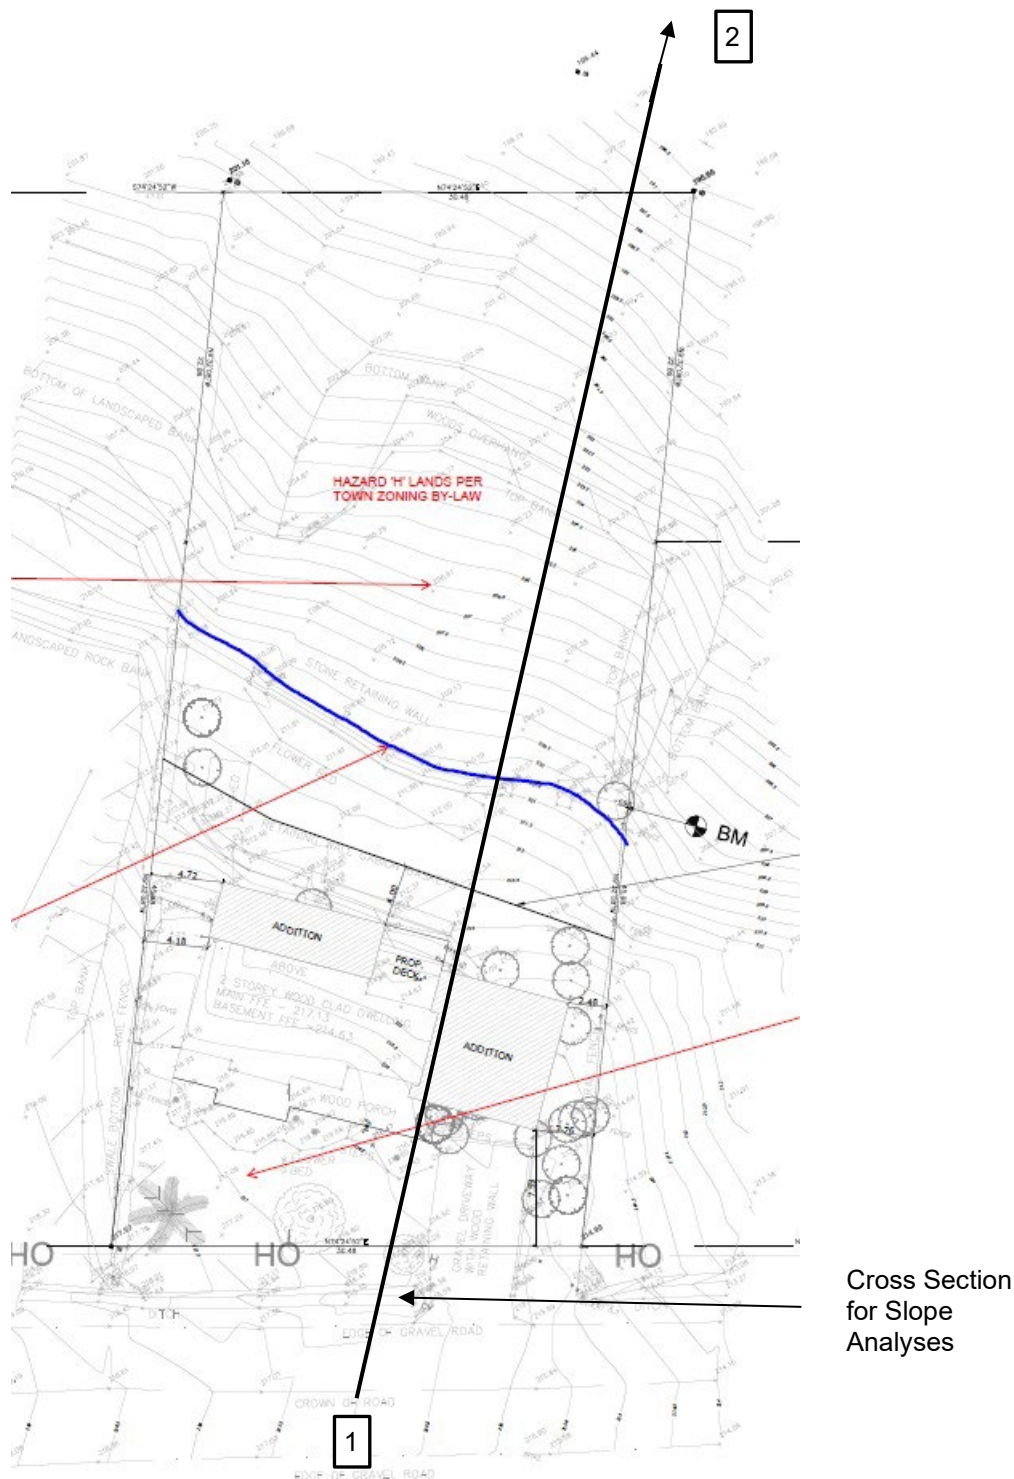
**Embedded Figure 1: Slope area and existing property**

Cross Section  
for Slope  
Analyses

The completed slope stability rating chart, according to the MNR Technical Guide, is included as Appendix A of this letter, and the results are described in the following section. As previously noted, the slope rating was determined for the assessed slope area shown on Embedded Figure 1 above.

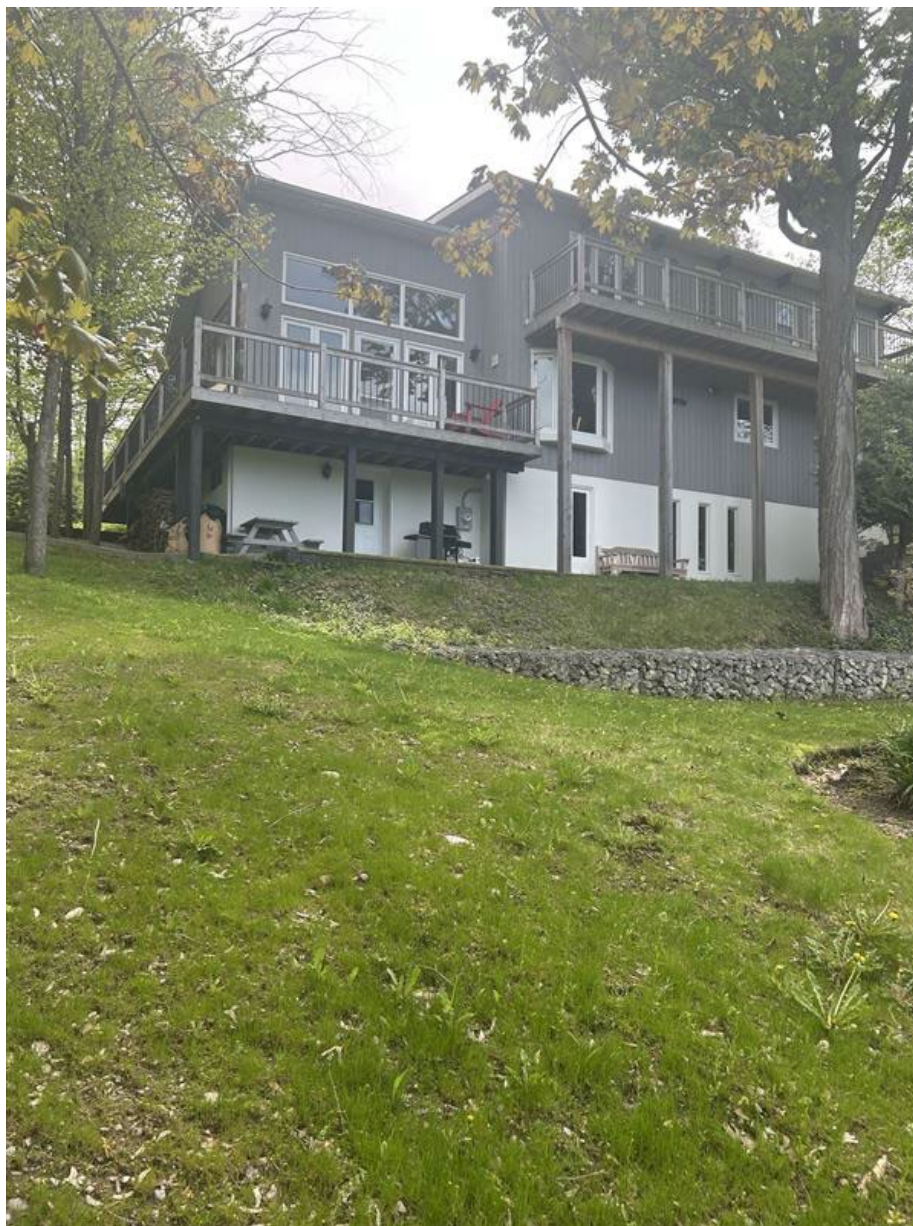
The existing property and slope are shown in Photograph 1 to Photograph 8, including the existing dwelling, existing retaining walls, the slope face, and table lands.

The table lands above the slope are generally grassed with large mature trees and generally slope down towards the top of the slope from Hidden Lake Road at the south end of the property. The existing dwelling exhibits no visual signs of differential settlement with no cracks observed in the concrete foundation/basement walls. Roof drainage from the existing dwelling is currently carried through drainage pipes down to just below the concrete block retaining wall. There are some signs of erosion and erosion repairs around the drainage pipes. There are also some signs of erosion by way of small gullies in areas around the retaining walls.

*Photograph 1 – View of rear extent of existing dwelling (looking south)*

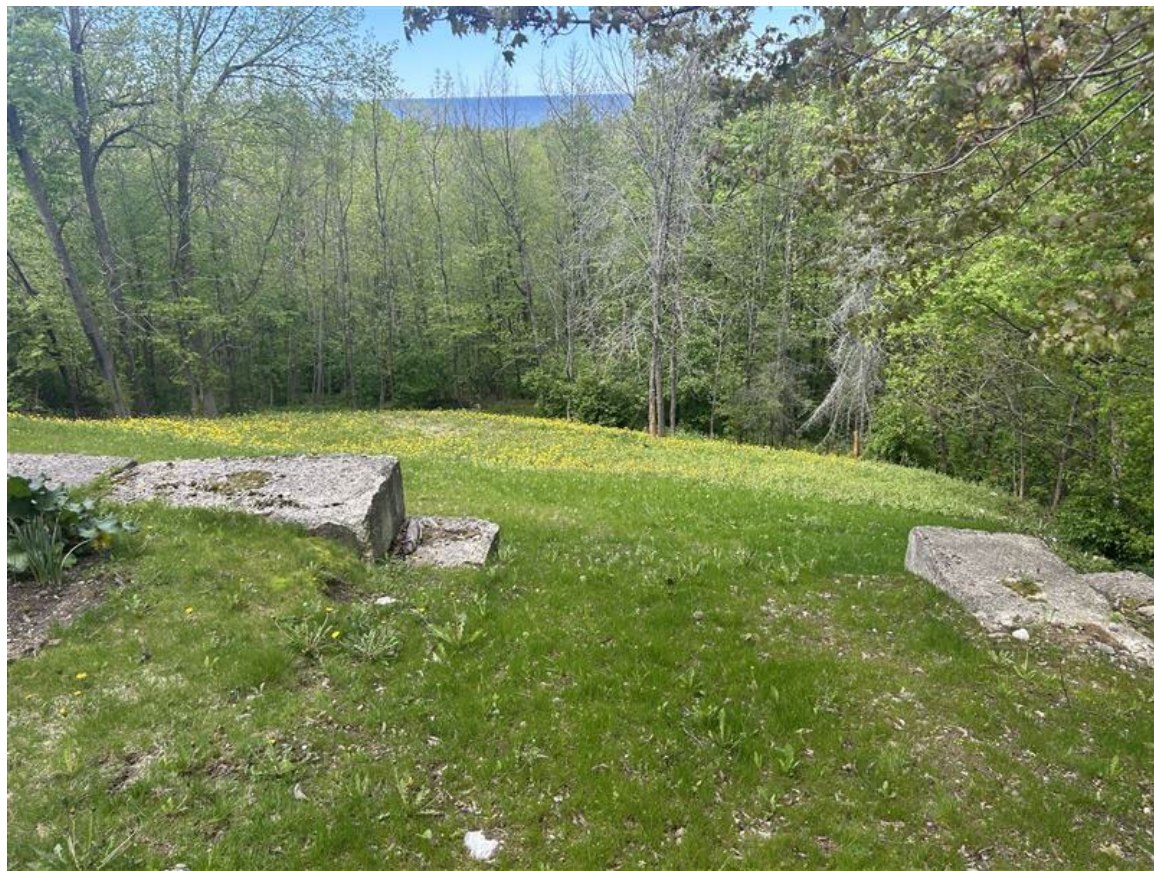
**Photograph 2 – View looking north from concrete block retaining wall**

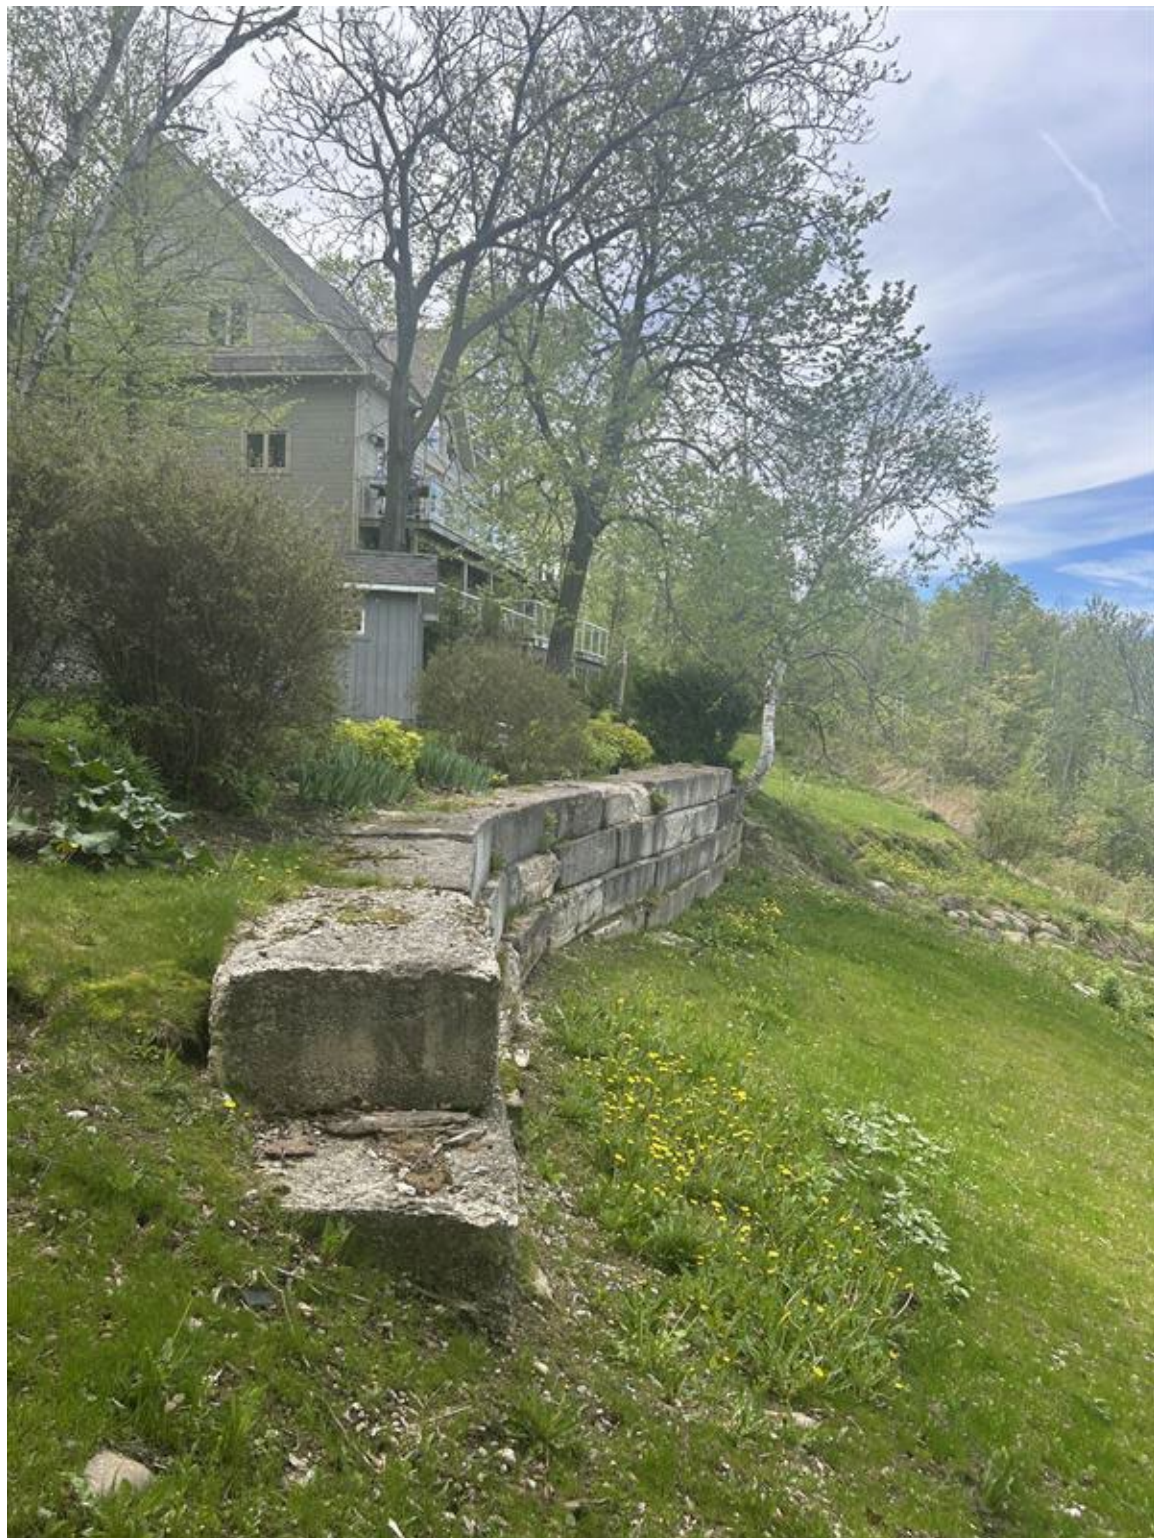
The two retaining walls are generally in sound condition with no visual signs of failures within the walls. Some weathering of the concrete blocks was observed. Some soil cracks and gullies were observed below the concrete retaining wall which are likely the result of some minor settlement of the backfilled soils around the retaining wall and drainage erosion.

**Photograph 3 – View of concrete block retaining wall looking west**

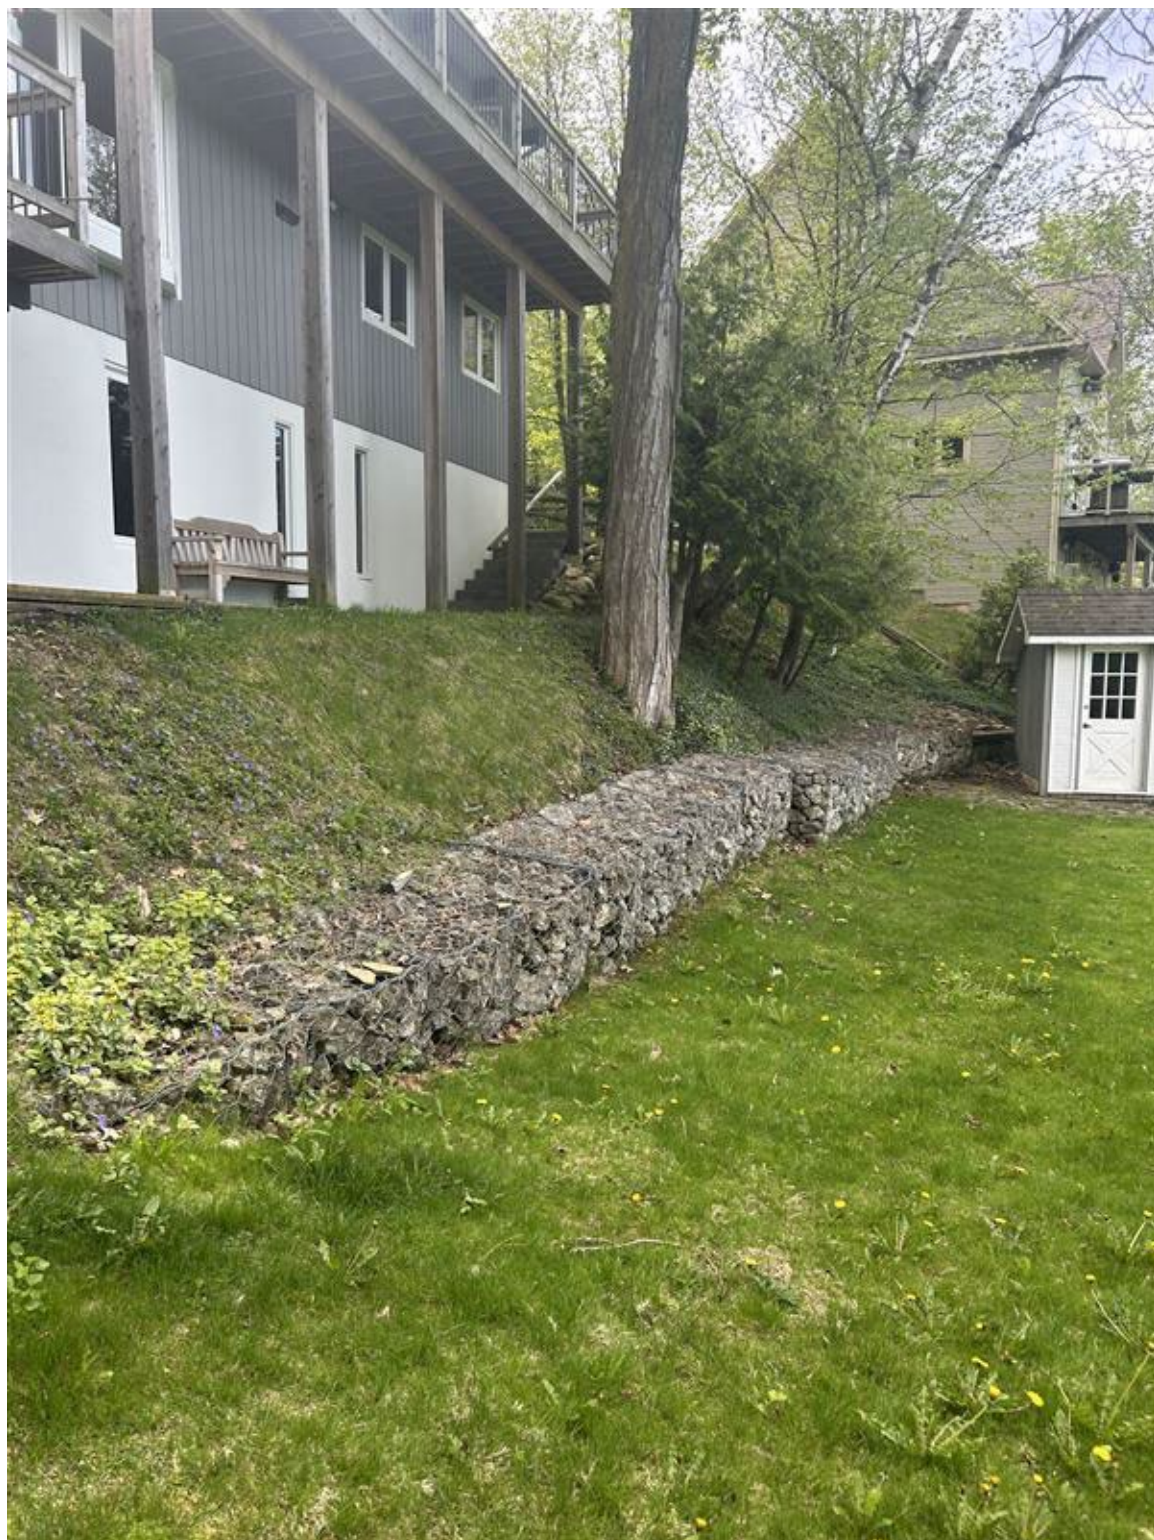
**Photograph 4 – View of gabion basket retaining wall looking west**

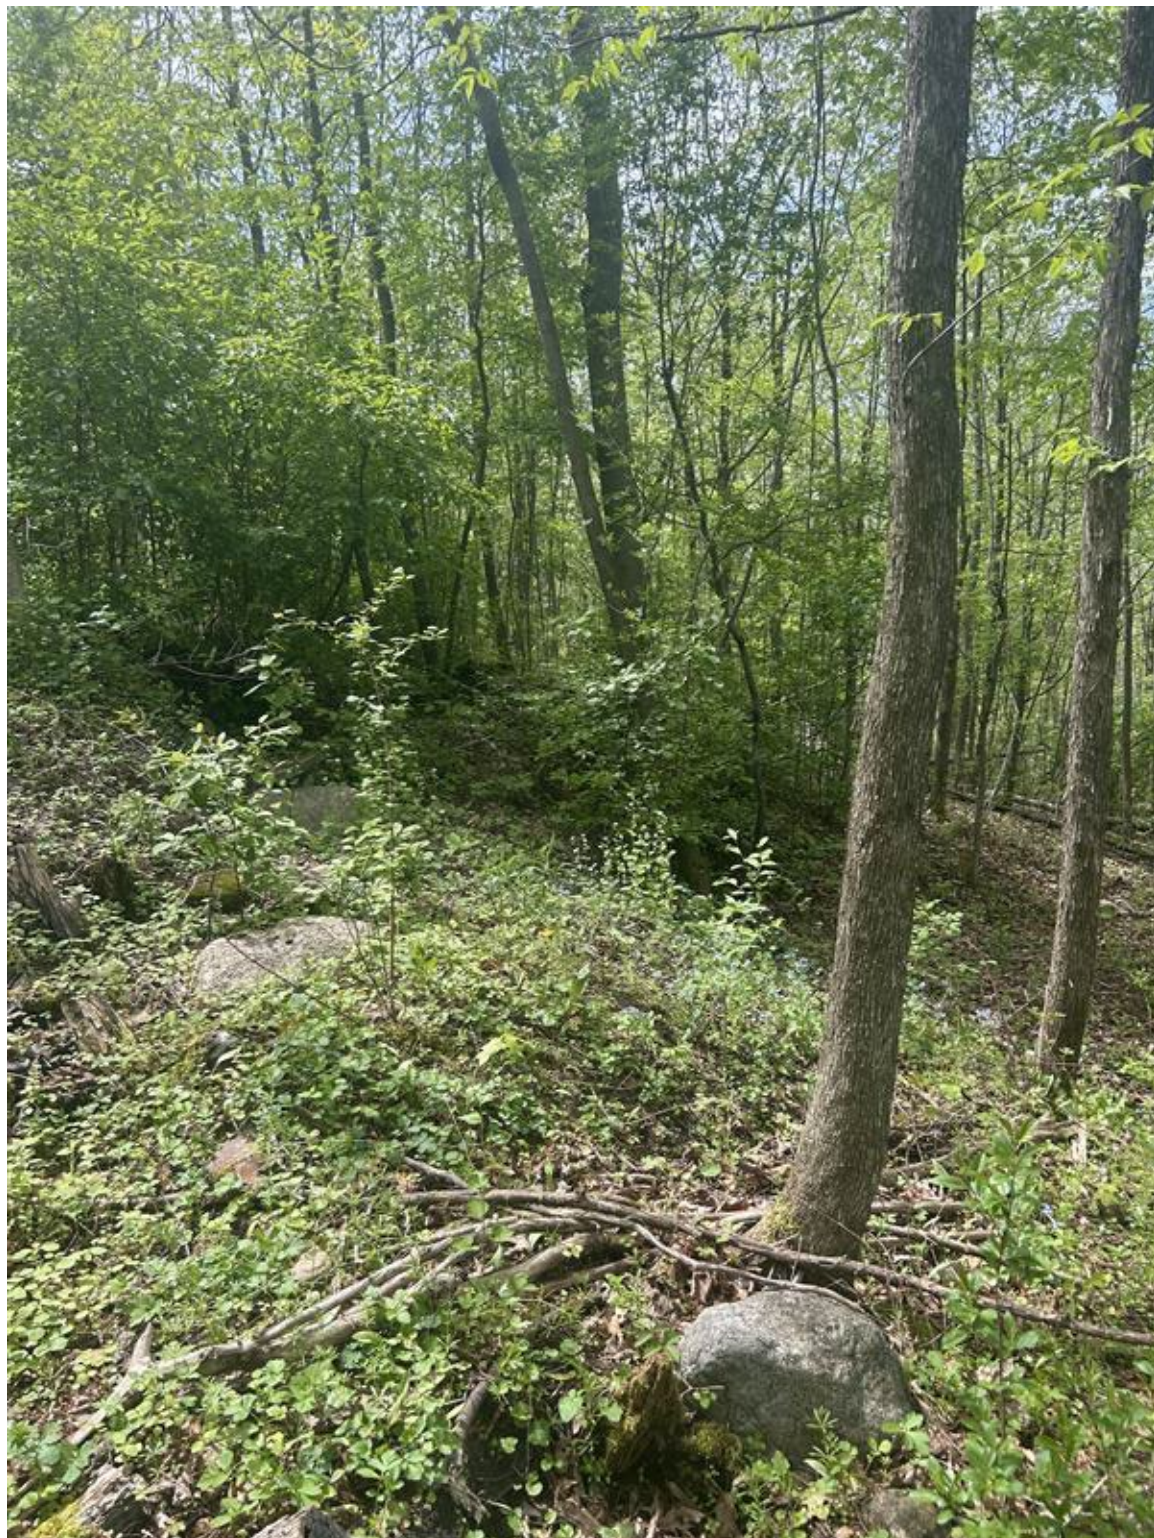
The base of the slope is located approximately 110 m south of the existing dwelling in a heavily forested area. There was no obvious signs of erosion at the toe of the slope. A small creek was located approximately 25 m north of the toe of the slope and ran perpendicular to the slope in a generally east to west direction.

**Photograph 5 – View of forested area near toe of slope**

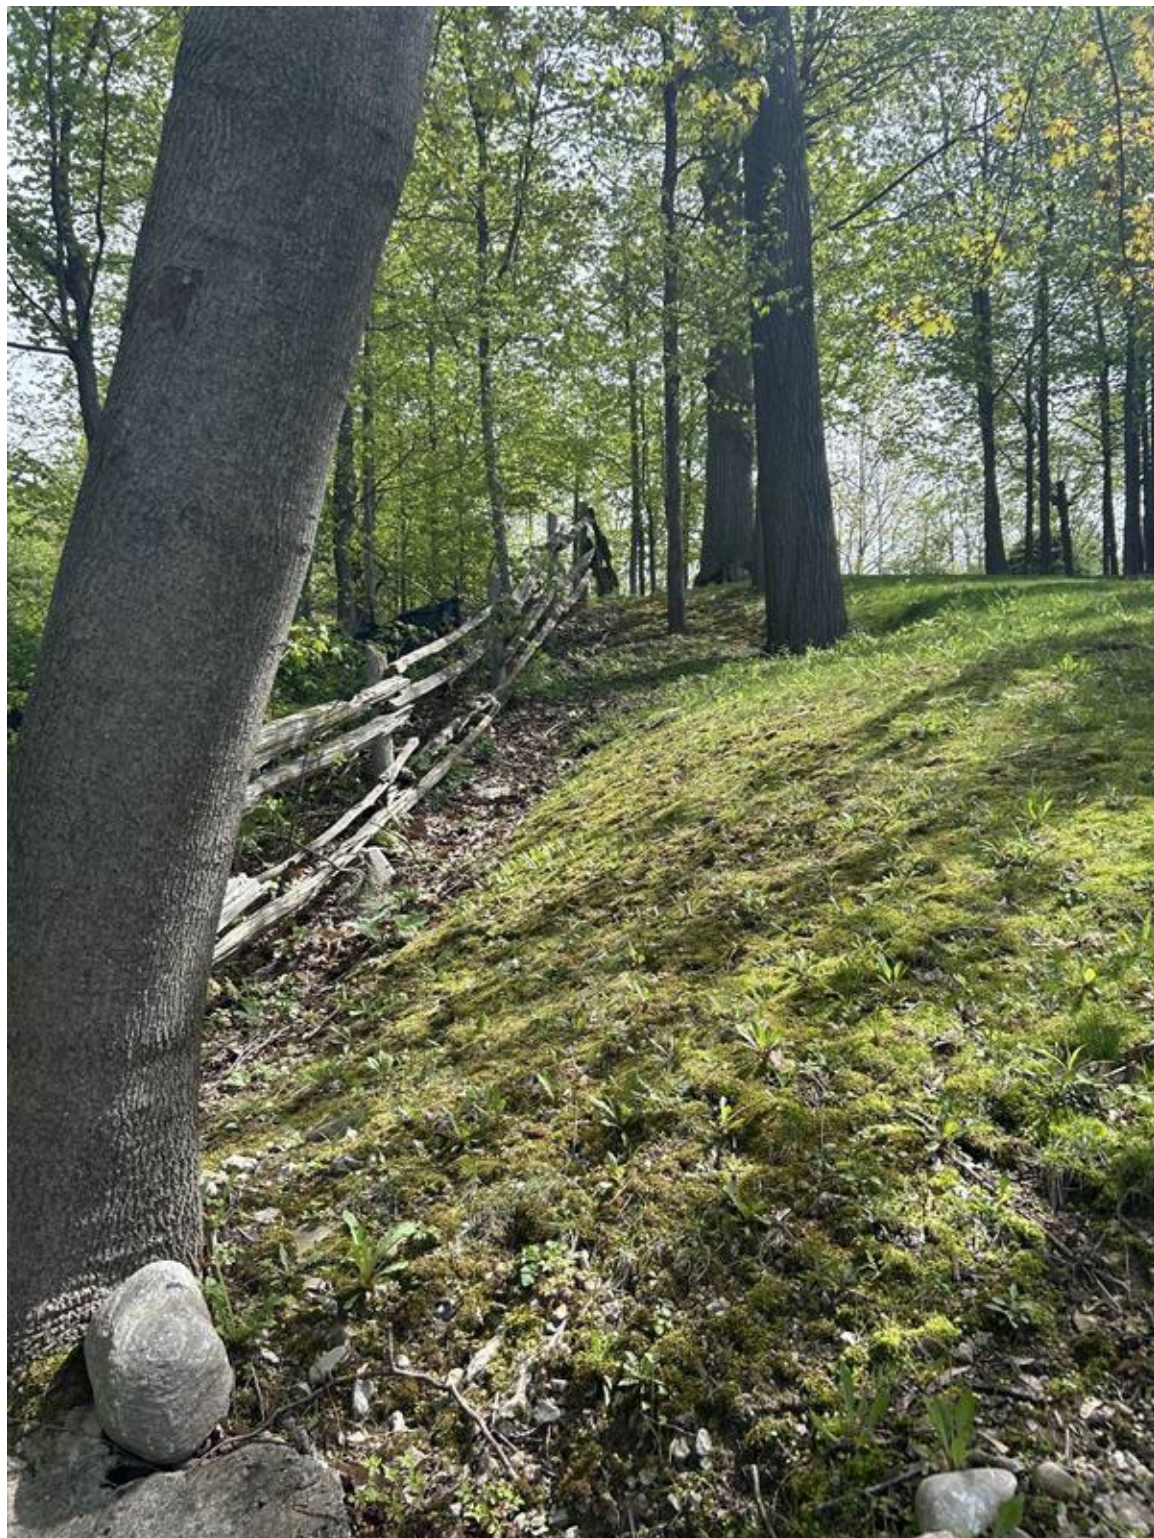
**Photograph 6 – View of east side of property looking south**

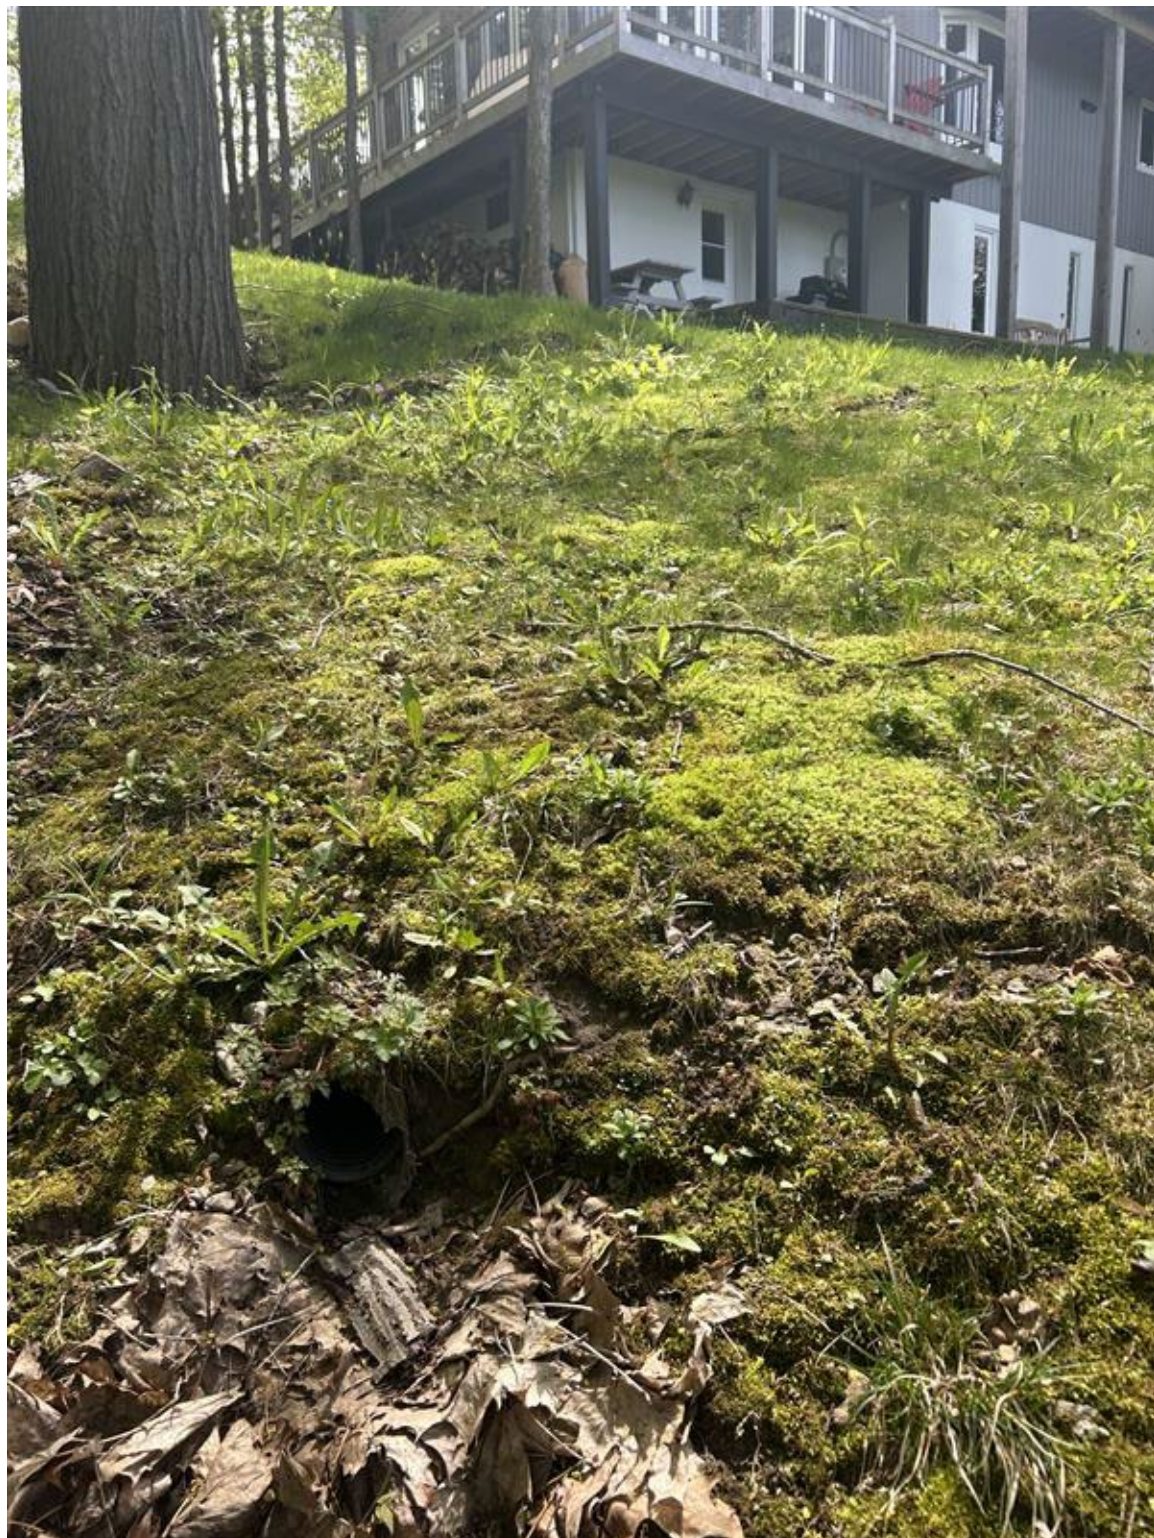
6. Table land drainage: The table land generally has a slight slope down from the south edge of the property towards the top of the slope. Roof drainage from the existing dwelling is controlled by drainage pipes extending down to below the retaining walls. There are some visual signs of erosion due to drainage over the slope and around drainage pipes. A rating value of **4** is recommended.
7. Proximity of watercourse to slope toe: a small creek was located approximately 25 m north of the toe of the slope. Therefore, a rating value of **0** is recommended.
8. Previous landslide activity: No evidence of previous landslide activity was confirmed, giving a rating of **0**.

***Photograph 7 – View of drainage pipe outflow***

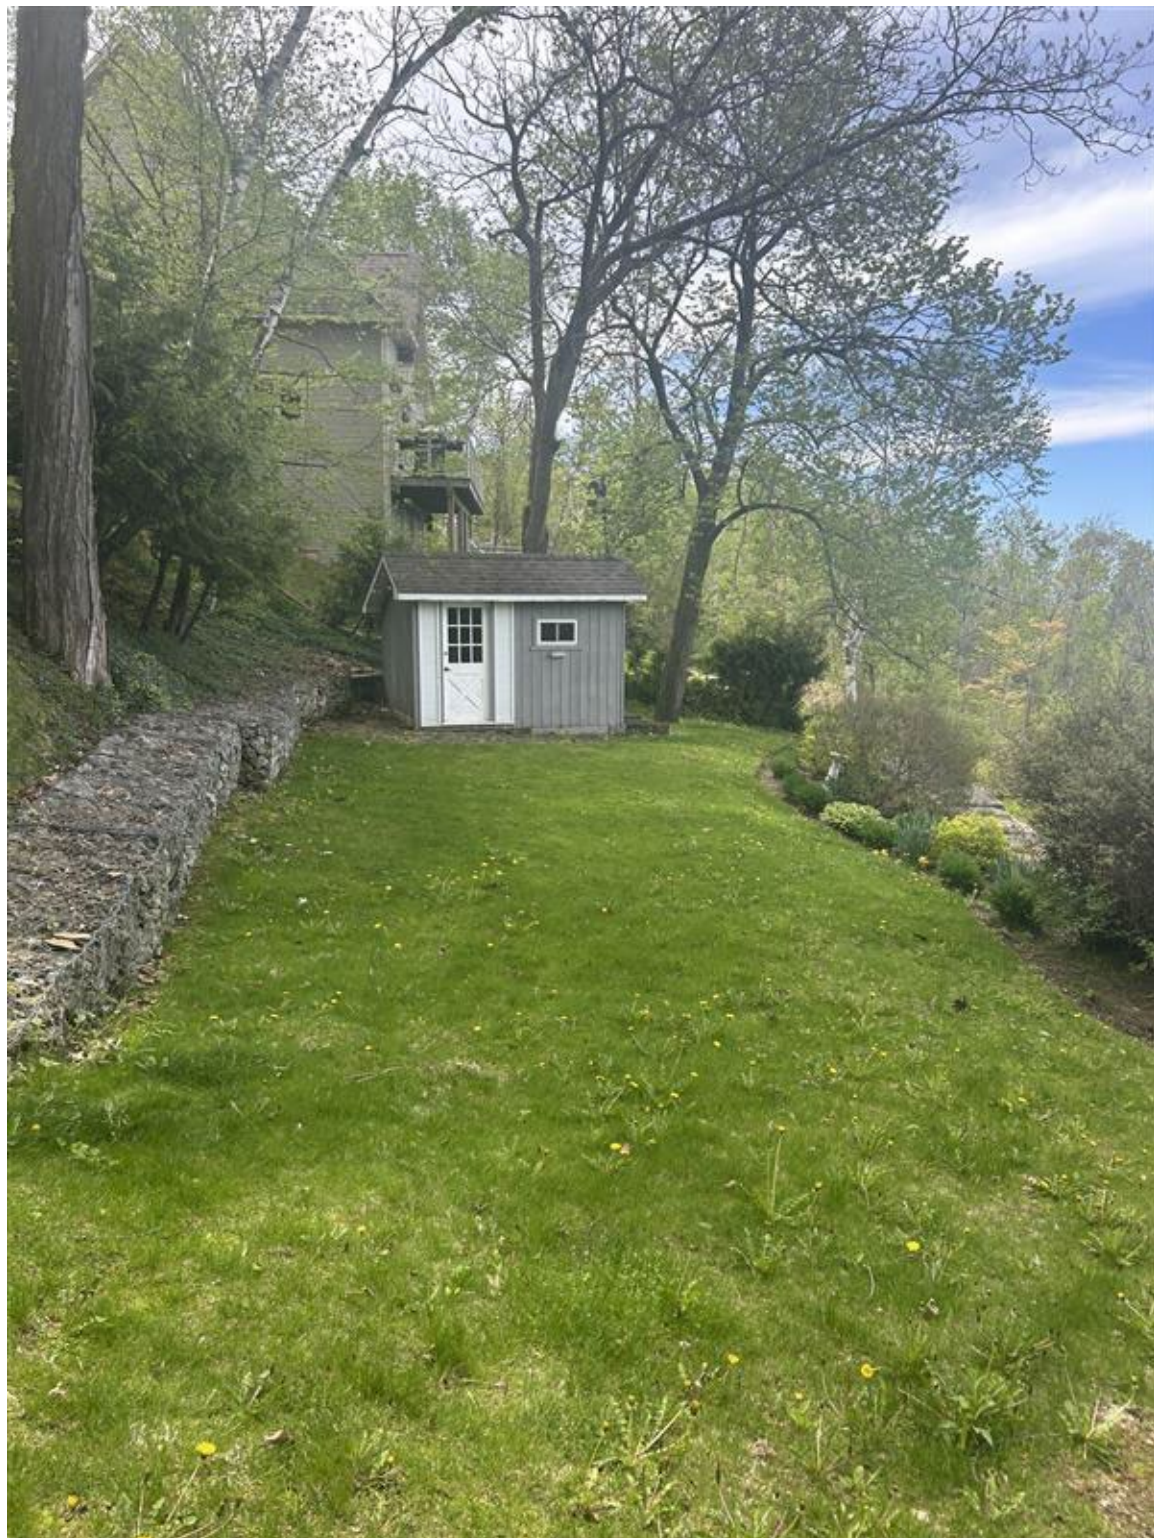
**Photograph 8 – View of existing shed looking west**

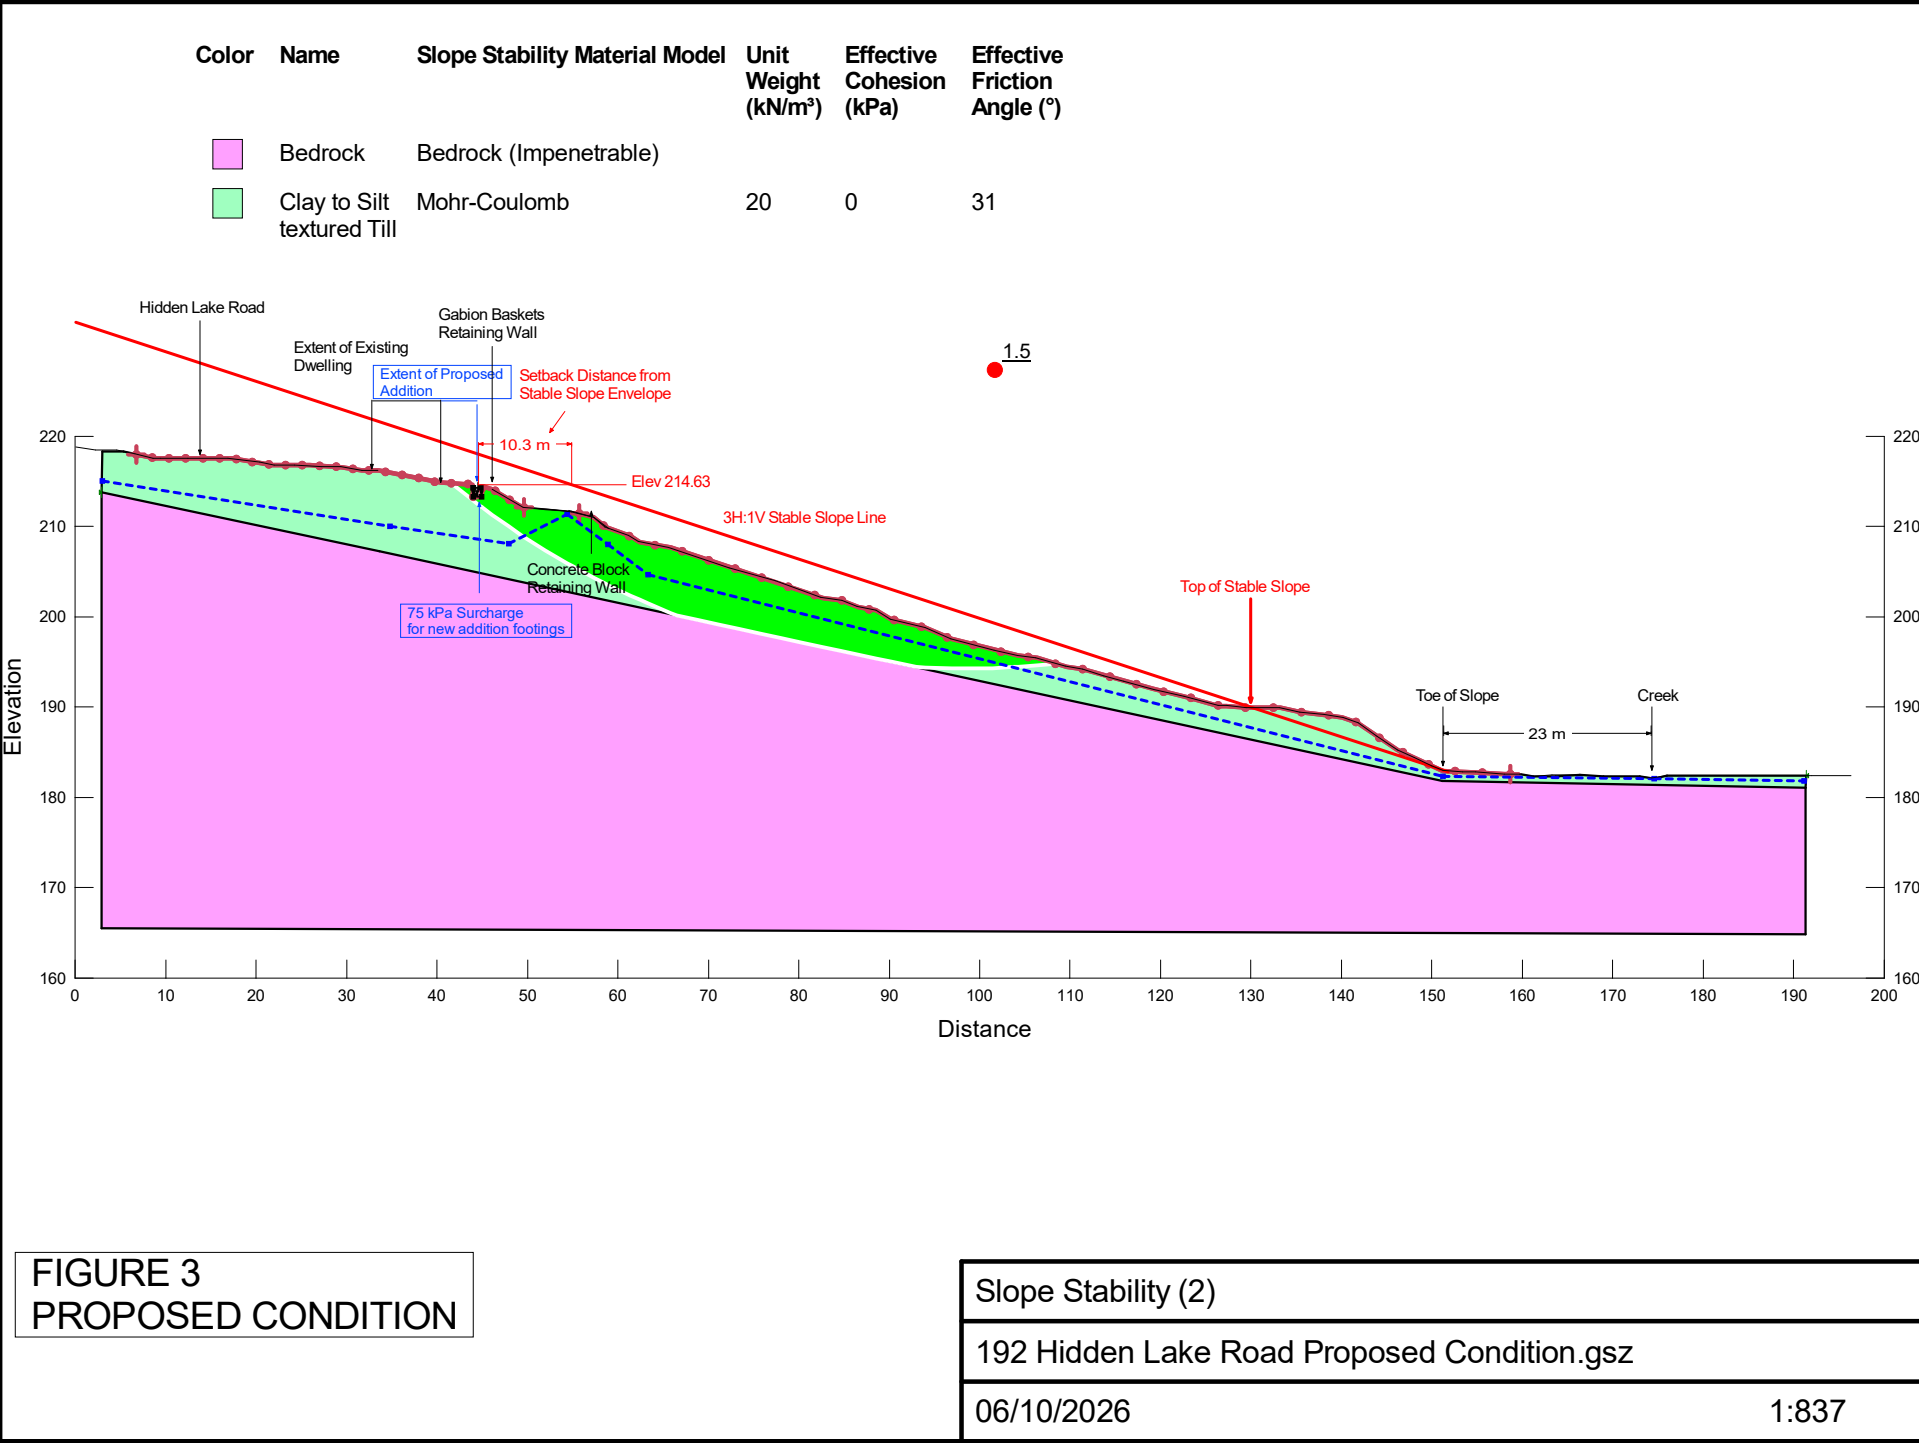
- Loading Case 2 – Proposed Conditions: The analysis indicates that the assessed slope has an estimated factor of safety of 1.5 against deep-seated/global failure when a surcharge is applied from the extent of the proposed dwelling addition. Detailed results for this loading case are provided on Figure 3 in Appendix C.

Based on the Stable Slope Line drawn from the toe of the slope, the Stable Top of Slope is located approximately 90 north of the existing dwelling and no part of the property encroaches into the Slope Hazard. As shown Figure 3, should the Stable Slope Line be extended up to the elevation of the Finished Floor Elevation (FFE) of the existing and proposed dwelling, the proposed addition would be setback approximately 10 m from the Stable Slope Envelope on that elevation plane, and thus the 6 m setback from the Stable Slope Line stipulated by the GSCA planning policy would be met.
