## **Proposed Three-Storey Apartment Buildings**

**Geotechnical Investigation**

150 & 160 King Street East, Thornbury, Ontario

BAR-00258217-A1

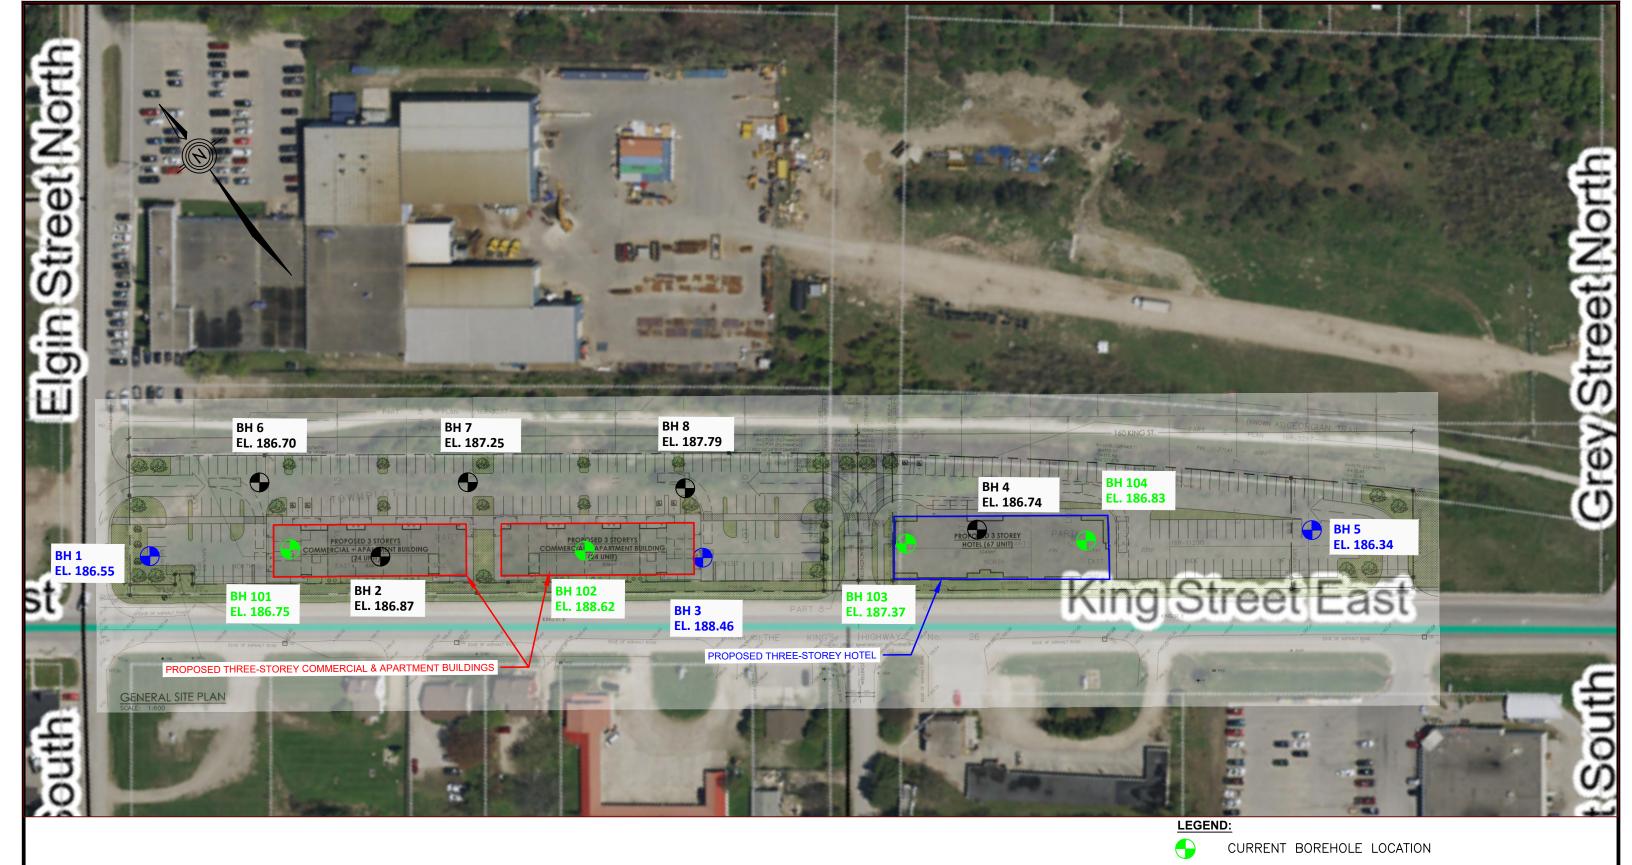
Drawing 1 – Borehole Location Plan

PREVIOUS BOREHOLE LOCATION

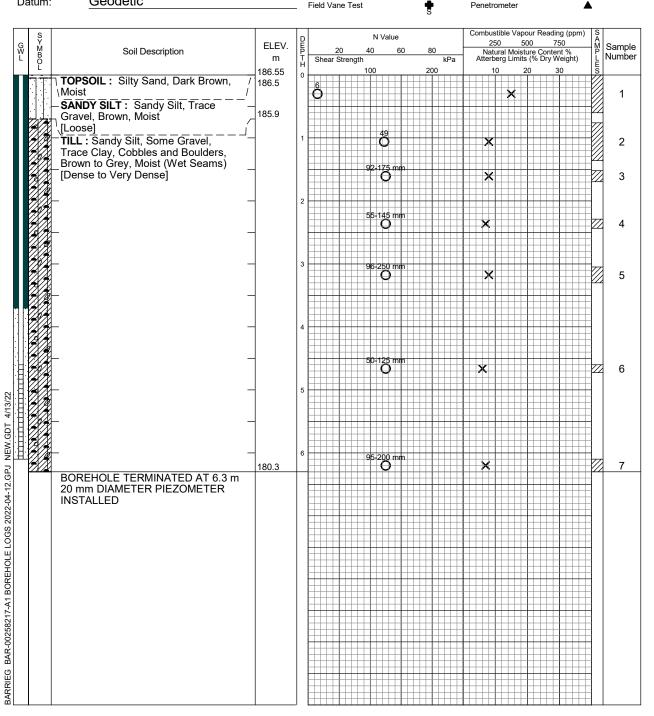
Project No.	BAR-00258217-A0			Figure No.	2	
Project: City/ Municipality:	Proposed Three-Storey Hotel & Ap Thornbury, ON	partment Building	js .	Sheet No.	_1_ of	_1
Location:  Date Drilled:	17T 4934130 544071 March 24, 2020	Auger Sample		Combustible Vapour Reading Natural Moisture	□ <b>X</b>	
Orill Type:	Solid Stem Augers Geodetic	SPT (N) Value  Dynamic Cone Test  Shelby Tube	0 🗵	Plastic and Liquid Limit F Undrained Triaxial at % Strain at Failure	——○ ⊕

Time	Water Level (m)	Depth to Cave (m)
Upon Completion	5.8	Open
March 31, 2020	2.6	-

The detailed soil profile encountered in each borehole and the results of laboratory moisture contents are indicated on the attached borehole logs. It should be noted the soil boundaries indicated on the borehole logs are inferred from non-continuous sampling and observations during drilling. These boundaries are intended to reflect approximate transition zones for the purpose of geotechnical design and should not be interpreted as exact planes of geological change. The "Notes on Sample Descriptions" (Figure 1) preceding the borehole logs (Figures 2 to 13) form an integral part of, and should be read in conjunction with, this report.

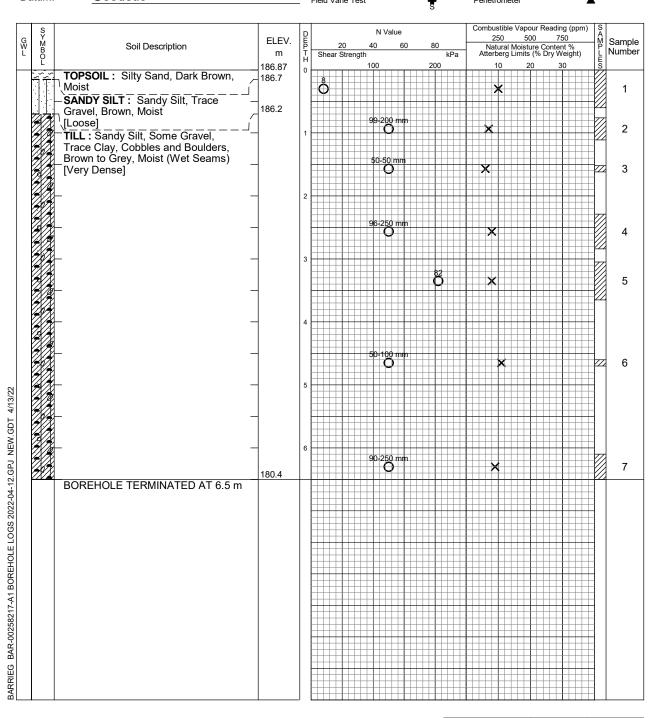
Project No.	BAR-00258217-A0			Figure No.	3	}
Project: City/	Proposed Three-Storey Hotel & Ap	artment Building	js <u> </u>	Sheet No.	. <u>1</u> of	f <u>1</u>
Municipality:	Thornbury, ON					
Location:	17T 4934090 544124			Combustible Vapour Readir	ng 🗌	
Date Drilled:	March 24, 2020	Auger Sample		Natural Moisture	×	
Drill Type:	Solid Stem Augers	SPT (N) Value  Dynamic Cone Test  Shelby Tube		Plastic and Liquid Limit Undrained Triaxial at % Strain at Failure	$\vdash$ $\oplus$	
Datum:	Geodetic	Field Vana Toot		Denetrometer

Water Level (m)	Depth to Cave (m)
No Water	Öpen
	Level (m)

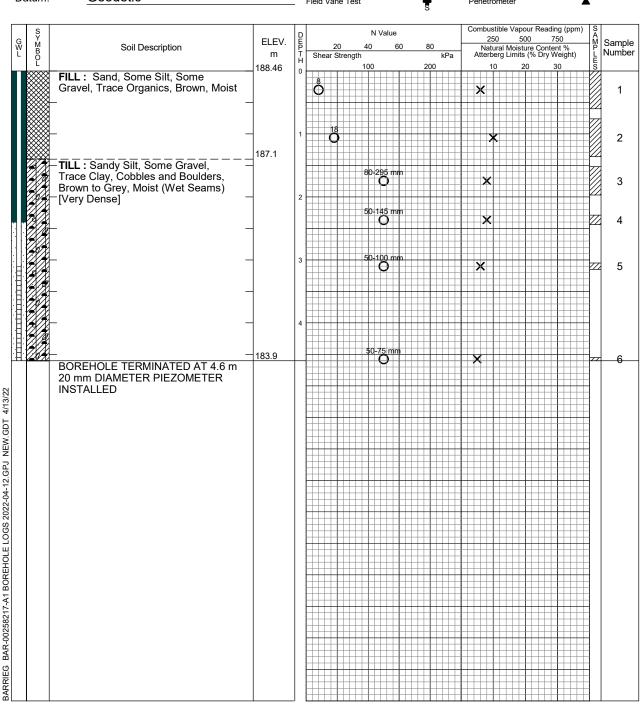
BAR-00258217-A0 Project No. Figure No. Proposed Three-Storey Hotel & Apartment Buildings Sheet No. 1 of 1 Project: City/ Thornbury, ON Municipality: Location: 17T 4934034 544198 Combustible Vapour Reading  $\boxtimes$ Auger Sample March 24, 2020 × Natural Moisture Date Drilled: SPT (N) Value Plastic and Liquid Limit -0 Drill Type: Solid Stem Augers Dynamic Cone Test Undrained Triaxial at  $\oplus$ Shelby Tube % Strain at Failure Geodetic Datum: Field Vane Test Penetrometer

Time	Water Level (m)	Depth to Cave (m)
Upon Completion	No Water	Open
March 31, 2020	2.7	-

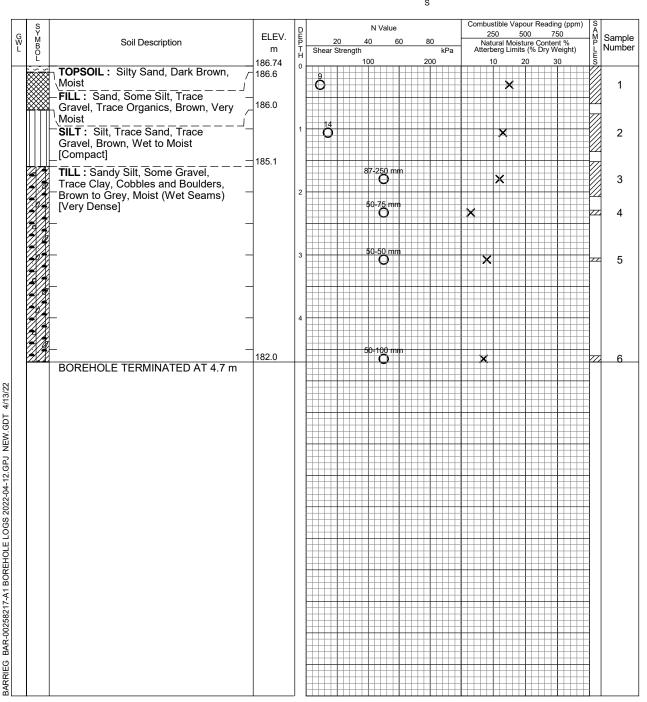
BAR-00258217-A0 Project No. Figure No. Proposed Three-Storey Hotel & Apartment Buildings Sheet No. 1 of 1 Project: City/ Thornbury, ON Municipality: Location: 17T 4933993 544266 Combustible Vapour Reading  $\boxtimes$ Auger Sample March 24, 2020 × Natural Moisture Date Drilled: SPT (N) Value OØ Plastic and Liquid Limit -0 Drill Type: Solid Stem Augers Dynamic Cone Test Undrained Triaxial at  $\oplus$ Shelby Tube % Strain at Failure Geodetic Datum: Field Vane Test Penetrometer

Time	Water Level (m)	Depth to Cave (m)
Upon Completion	1.5	4.0

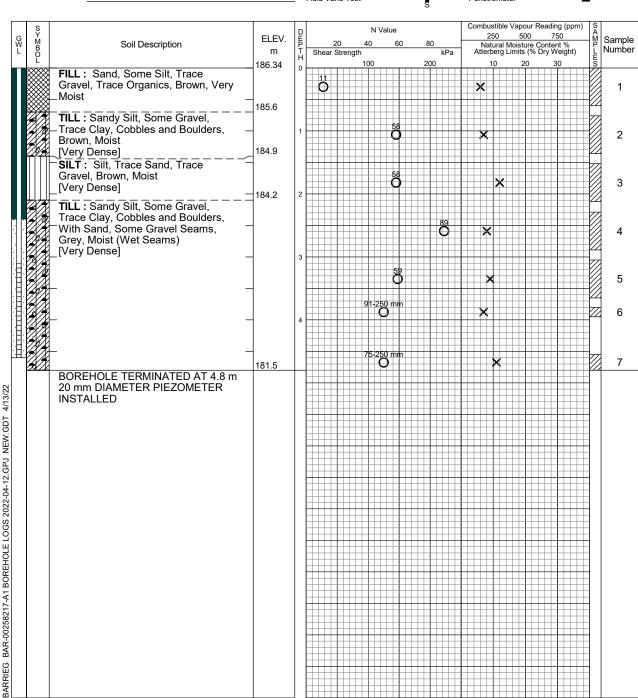
BAR-00258217-A0 Project No. Figure No. Proposed Three-Storey Hotel & Apartment Buildings Sheet No. 1 of 1 Project: City/ Thornbury, ON Municipality: Location: 17T 4933935 544343 Combustible Vapour Reading  $\boxtimes$ Auger Sample March 24, 2020 × Natural Moisture Date Drilled: SPT (N) Value -0 Plastic and Liquid Limit Solid Stem Augers Dynamic Cone Test Drill Type: Undrained Triaxial at  $\oplus$ Shelby Tube % Strain at Failure Geodetic Datum: Field Vane Test Penetrometer

Time	Water Level (m)	Depth to Cave (m)
Upon Completion	No Water	Open
March 31, 2020	0.0	-

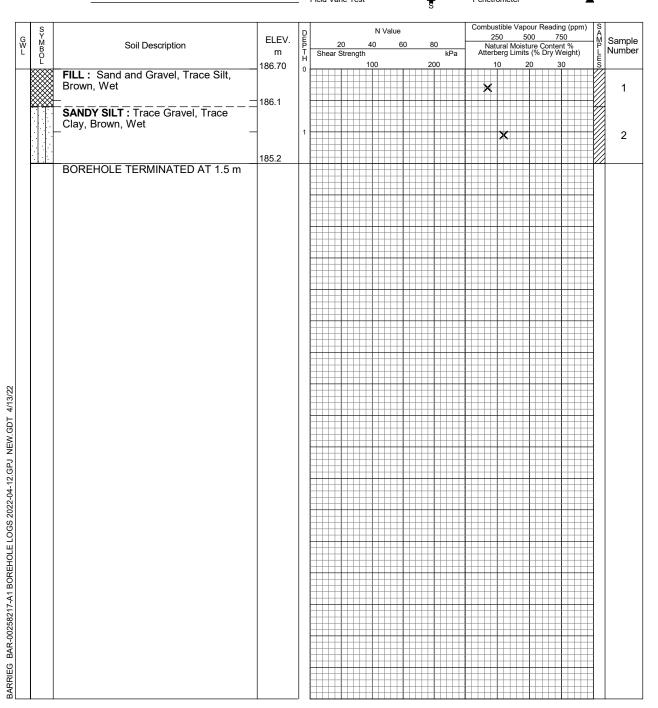
Project No.	BAR-00258217-A0			Figu	re No.	7	
Project:	Proposed Three-Storey Hotel & Ap	artment Building	js	She	et No.	_1_ of	1
City/ Municipality:	Thornbury, ON						
Location:	17T 4934128 544109			Combustible Vapou	r Reading		
Date Drilled:	March 24, 2020	Auger Sample		Natural Moisture	3	×	
Drill Type:	Solid Stem Augers	SPT (N) Value  Dynamic Cone Test  Shelby Tube		Plastic and Liquid L Undrained Triaxial a % Strain at Failure	_	——○ ⊕	
Datum:	Geodetic	Field Vane Test	_	Penetrometer		•

Time	Water Level (m)	Depth to Cave (m)
Upon Completion	0.3	0.3

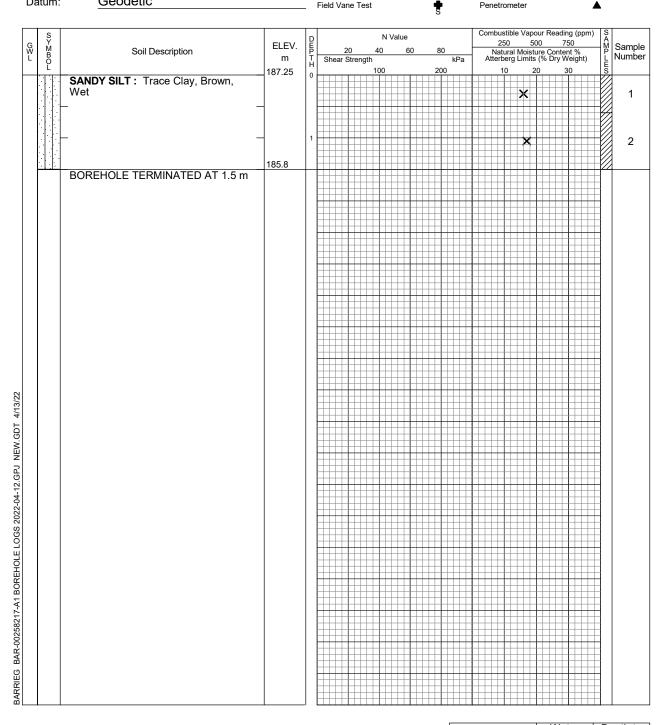
Project No.	BAR-00258217-A0				Figure No.		8	
Project:	Proposed Three-Storey Hotel & Ap	partment Buildin	gs		Sheet No.	_1_	of _	1
City/ Municipality:	Thornbury, ON							
Location:	17T 4934092 544157	-		Combustible	e Vapour Reading		1	
Date Drilled:	March 24, 2020	Auger Sample		Natural Moi	isture	×	(	
- ··· -	Calid Chara Assaura	SPT (N) Value	O 🛮	Plastic and	Liquid Limit		С	
Drill Type:	Solid Stem Augers	Dynamic Cone Test - Shelby Tube	_	Undrained <sup>-</sup> % Strain at		$\oplus$		
Datum:	Geodetic	Field Vane Test	•	Penetromet	ter	•

Time	Water Level (m)	Depth to Cave (m)
Upon Completion	1.2	Öpen

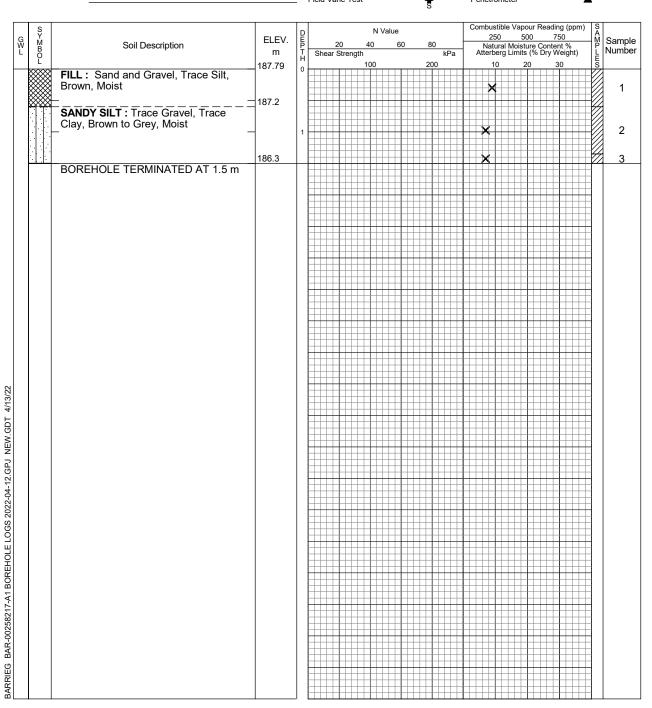
Project No.	BAR-00258217-A0			Figure No	o	9	
Project:	Proposed Three-Storey Hotel & Apa	artment Building	js	Sheet No	o. <u>1</u>	of	1
City/ Municipality:	Thornbury, ON						
Location:	17T 4934053 544206			Combustible Vapour Read	dina		
Date Drilled:	March 24, 2020	Auger Sample SPT (N) Value Dynamic Cone Test Shelby Tube	O ∅	Natural Moisture	3	×	
Drill Type:	Solid Stem Augers		Undrained	Plastic and Liquid Limit Undrained Triaxial at % Strain at Failure	<b>⊢</b>	<b>-</b> ○ }	
Datum:	Geodetic	Field Vane Test	_	Panetrometer

Time	Water Level (m)	Depth to Cave (m)
Upon Completion	No Water	Öpen

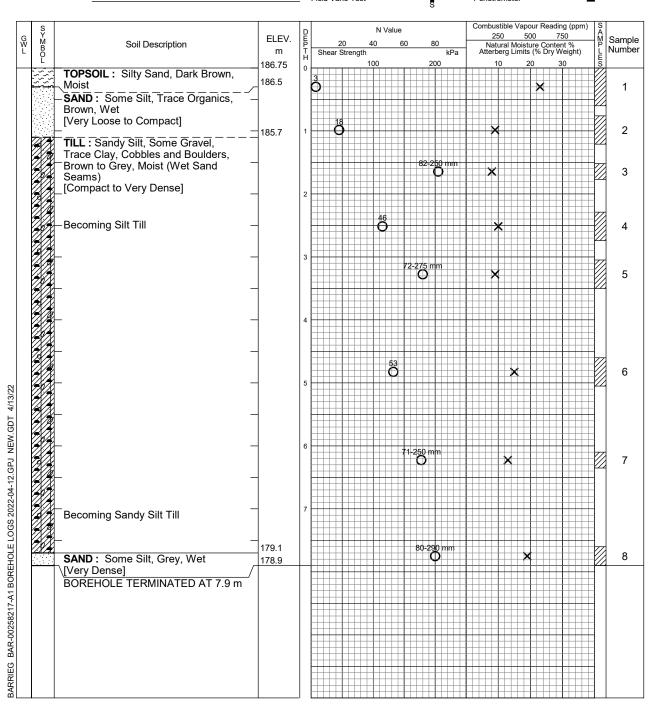
BAR-00258217-A0 Project No. Figure No. Proposed Three-Storey Hotel & Apartment Buildings Sheet No. 1 of 1 Project: City/ Thornbury, ON Municipality: Location: 17T 4934108 544099 Combustible Vapour Reading  $\boxtimes$ Auger Sample × April 11, 2022 Natural Moisture Date Drilled: SPT (N) Value Plastic and Liquid Limit -0 Drill Type: Solid Stem Augers Dynamic Cone Test Undrained Triaxial at  $\oplus$ Shelby Tube % Strain at Failure Geodetic Datum: Field Vane Test Penetrometer

Time	Water Level (m)	Depth to Cave (m)
Upon Completion	2.1	Open

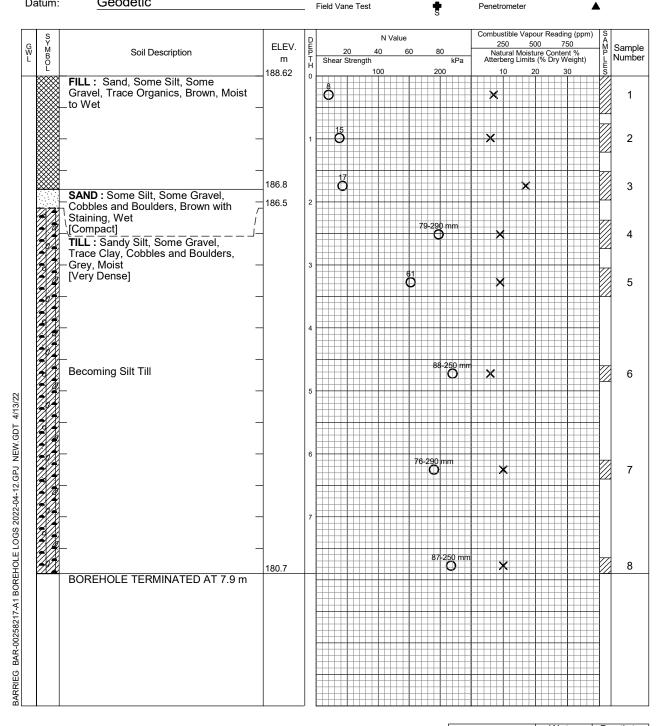
BAR-00258217-A0 Project No. Figure No. Proposed Three-Storey Hotel & Apartment Buildings Sheet No. 1 of 1 Project: City/ Thornbury, ON Municipality: Location: 17T 4934052 544174 Combustible Vapour Reading  $\boxtimes$ Auger Sample × April 11, 2022 Natural Moisture Date Drilled: SPT (N) Value Plastic and Liquid Limit -0 Solid Stem Augers Dynamic Cone Test Drill Type: Undrained Triaxial at  $\oplus$ Shelby Tube % Strain at Failure Geodetic Datum:

Time	Water Level (m)	Depth to Cave (m)
Upon Completion	No Water	Öpen

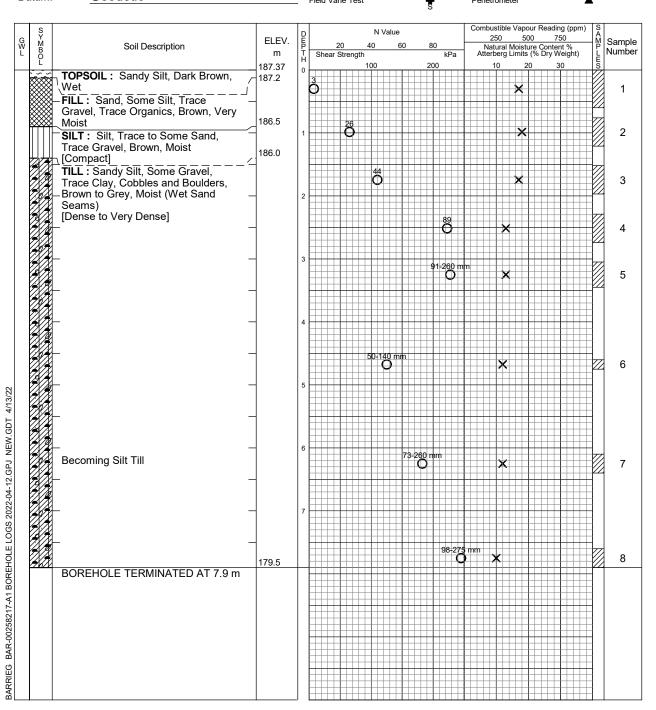
BAR-00258217-A0 12 Project No. Figure No. Proposed Three-Storey Hotel & Apartment Buildings Sheet No. 1 of 1 Project: City/ Thornbury, ON Municipality: Location: 17T 4934003 544239 Combustible Vapour Reading  $\boxtimes$ Auger Sample April 11, 2022 × Date Drilled: Natural Moisture SPT (N) Value Plastic and Liquid Limit -0 Solid Stem Augers Dynamic Cone Test Drill Type: Undrained Triaxial at  $\oplus$ Shelby Tube % Strain at Failure Geodetic Datum: Field Vane Test Penetrometer

Time	Water Level (m)	Depth to Cave (m)
Upon Completion	2.1	Öpen

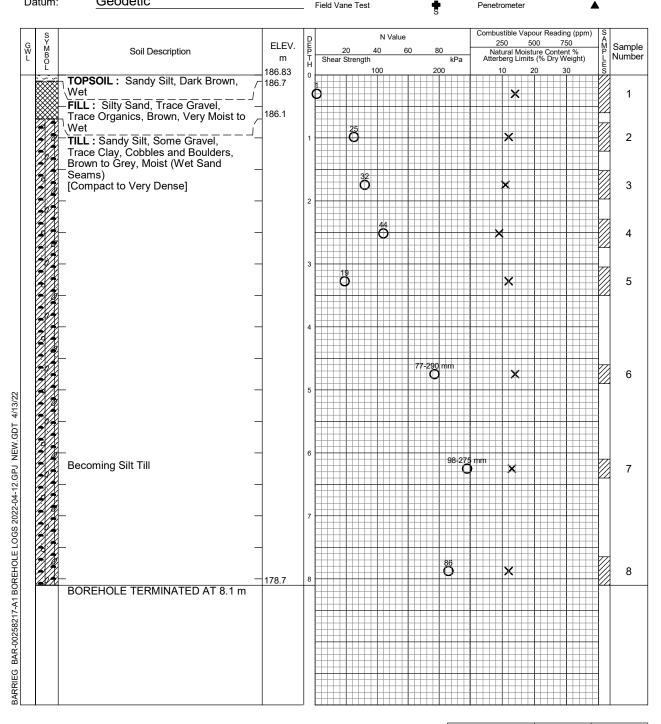
BAR-00258217-A0 Project No. Figure No. Proposed Three-Storey Hotel & Apartment Buildings Sheet No. 1 of 1 Project: City/ Thornbury, ON Municipality: Location: 17T 4933975 544279 Combustible Vapour Reading  $\boxtimes$ Auger Sample April 11, 2022 × Natural Moisture Date Drilled: SPT (N) Value Plastic and Liquid Limit -0 Drill Type: Solid Stem Augers Dynamic Cone Test Undrained Triaxial at  $\oplus$ Shelby Tube % Strain at Failure Geodetic Datum: Field Vane Test

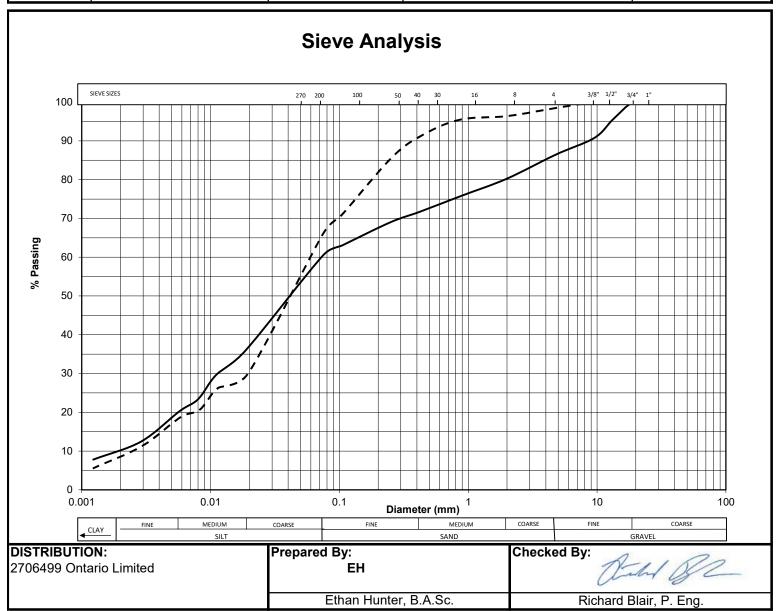
Project No.:BAR-00258217-A1Date Tested:March 27, 2020Client:2706499 Ontario LimitedDate Sampled:March 24, 2020

SAMPLE INFORMATION				
Material	Borehole No. and Sample No.	Sample Depth	Material Description	Graph Line Type
1	BH1 SS3	1.5 - 1.7	TILL: Sandy Silt, Some Gravel, Trace Clay	
2	BH7 SS1	0.0 - 0.6	Sandy Silt, Trace Clay
